Difficult Geologic Conditions Mandate Retaining Wall Redesign

Donald R. McMahon, P.E., M.ASCE¹, Andrew J. Nichols, P.E., M.ASCE¹ and Brian T. Contino, P.E.²

ABSTRACT

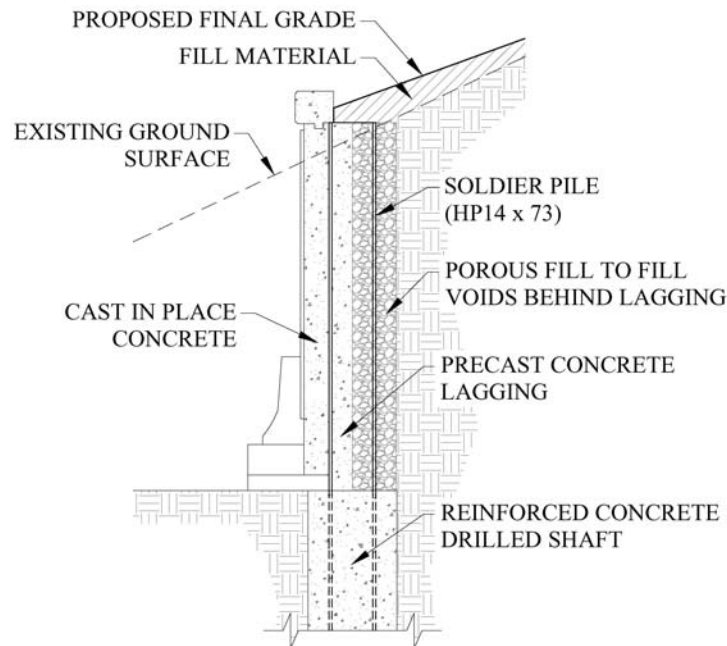
Figure 1. Top-down retaining wall section.

The site topography can be described as rolling. Within the limits of RW-8, the highway grade rises gently to the north, but the ground on the outside of the pavement slopes upward about 20 to 25 feet. Thus, the highway widening required a wall to maintain a manageable slope outside the highway limits. Figure 1 shows a section view of the proposed top-down wall and the ground surface conditions.

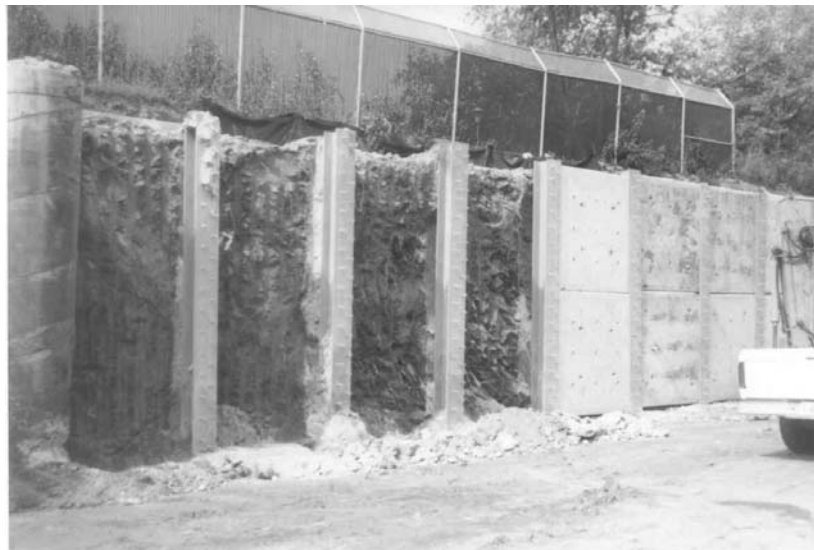
Figure 2. Top-down wall before lagging installation.

The contractor had successfully completed drilling some excavations for the soldier piles and had placed them in the drilled excavations. It excavated the sloped soil in front of the soldier piles, extending the excavation with an unsupported vertical face to the back flange of the soldier piles, as shown in Figure 2 to allow installation of the concrete lagging between the soldier piles and drainage material behind the lagging. These excavations allowed an indirect measure of the soil undrained shear strength.

In two locations along the RW-8 alignment, the contractor had left excavations between the soldier piles for the lagging (similar to the conditions shown in Figure 2) open for several weeks before installing the lagging. The excavations appeared stable and the ground surface at the top of the excavations showed no indication of lateral movement, such as tension cracks or sloughing. The excavation height was 16.5 feet.

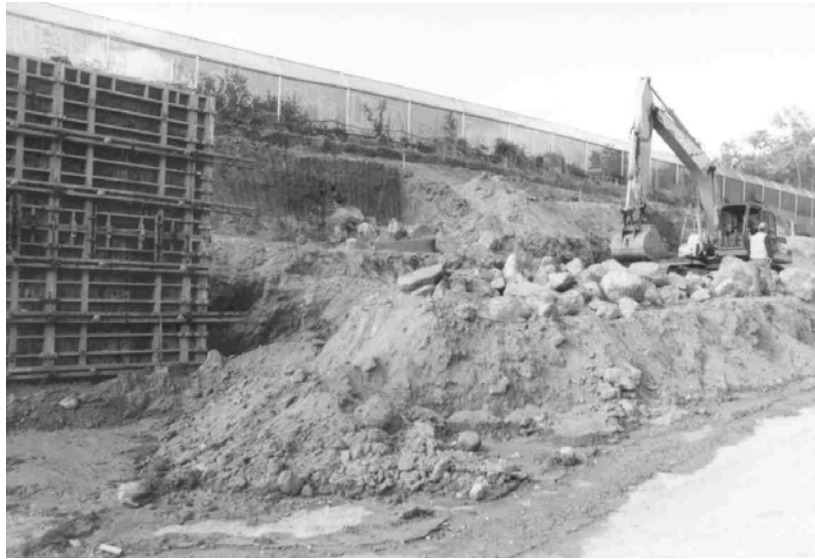
Figure 5. Excavation of Section 1.

Figure 5 shows the excavation of Section 1 in progress and the boulders removed from the excavation. This amount of boulders was the cause for the drilling difficulties.
