PROJECT DESCRIPTION

Elmwood Franklin School Project

Location:
Buffalo, New York

Client:
Elmwood Franklin
School

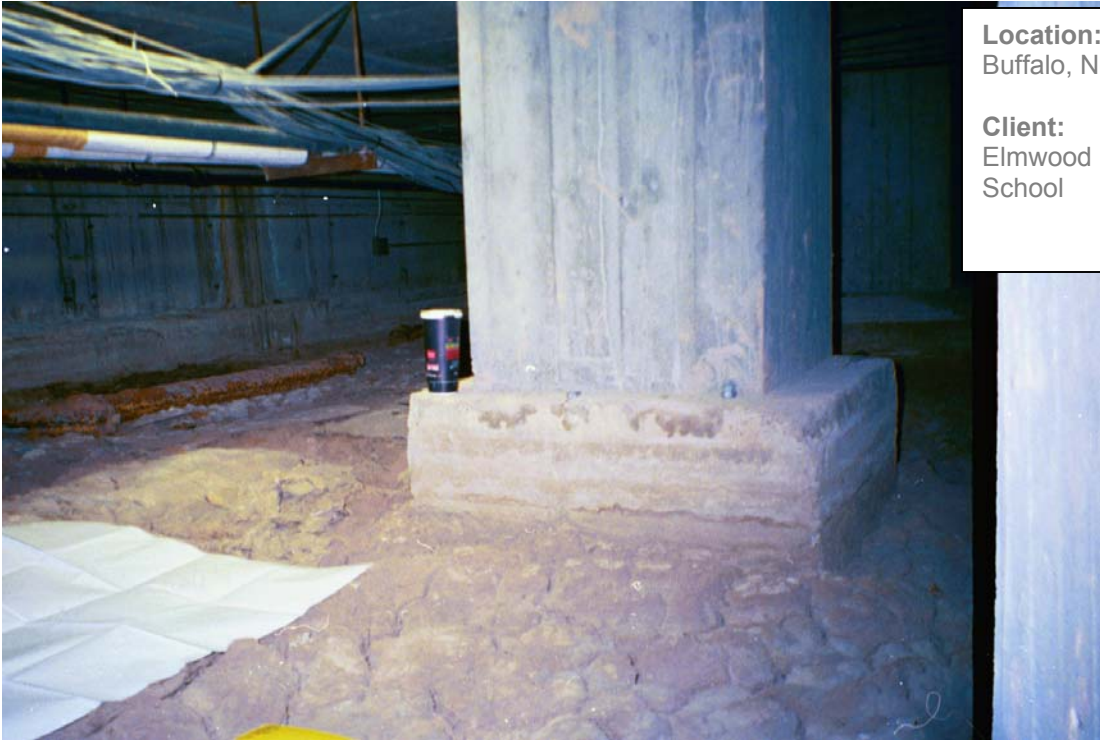
View of Elmwood Franklin Foundation

The cast-in-place first floor is supported by footings constructed on a clay subgrade. As shown in the above photograph, the subgrade has dried over time from actively ventilating the crawl space.

MMCE drilled borings inside the existing crawl space and outside of the school to collect samples for moisture content analysis. MMCE observed that the soil below the interior footings had dried to below the bottom of the borings. MMCE recommended that the school maintenance department hydrate the subgrade and have its surveyor establish a series of observation points on the structure to monitor the structure's response to the subgrade hydration. The survey data show that the clay swelled after it hydrated and that the floor heaved and the cracks in the walls closed.
