**ROCK SLOPE STABILIZATION PROJECTS  
LETCHWORTH STATE PARK  
PORTAGEVILLE, NEW YORK**

**INTRODUCTION**

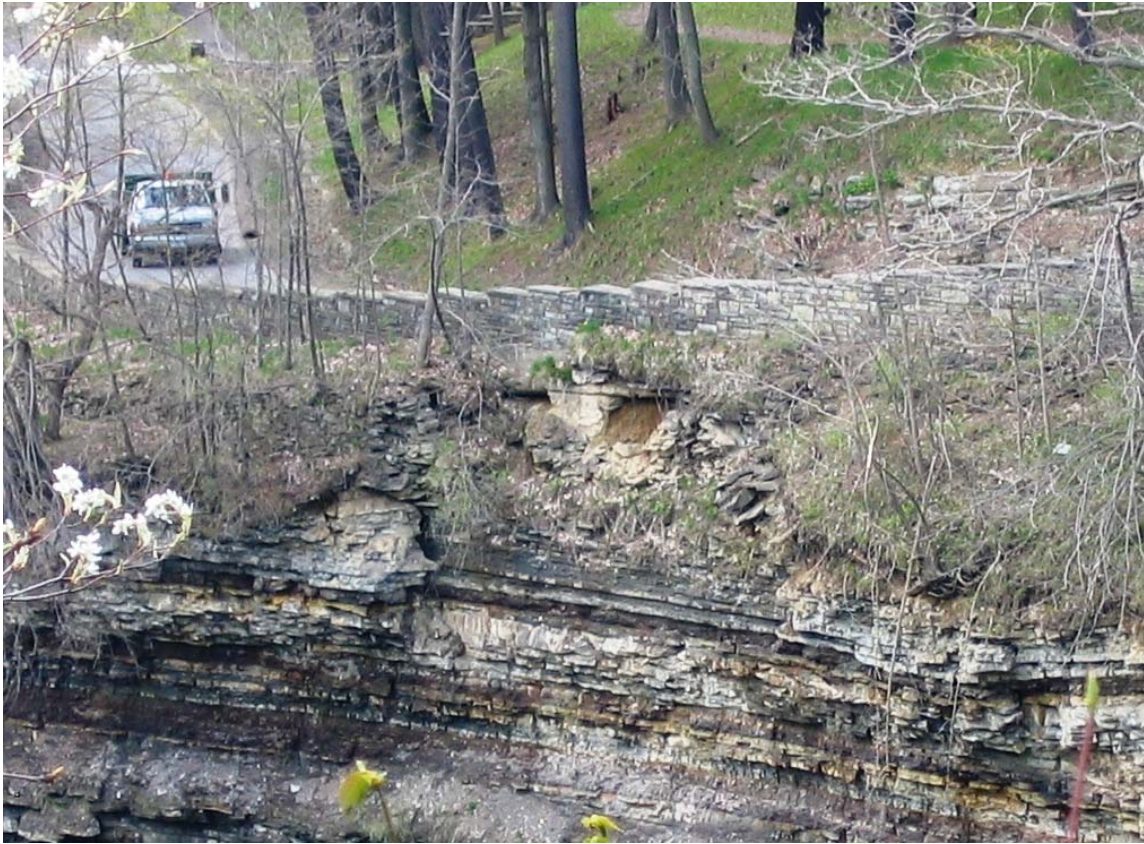
from the opposite (east) side of the gorge (see Figure 1) and noted some apparent irregularities in the gorge wall at this location.

*Figure 2 - Photo by OPRHP personnel of west side of gorge.*

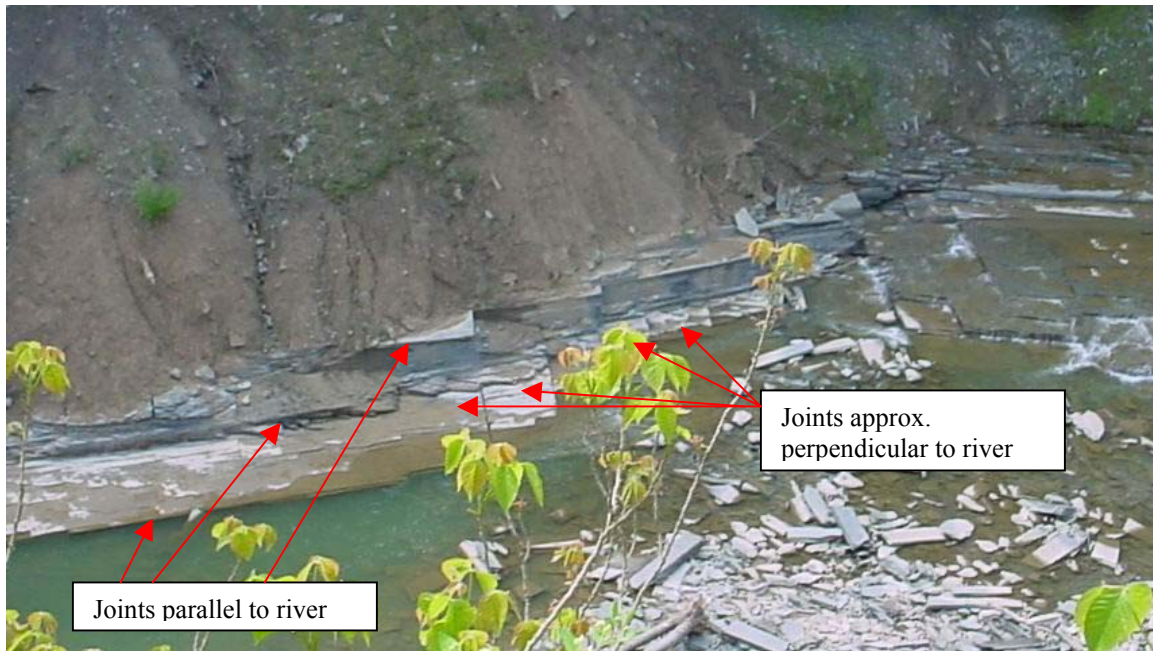
We observed the rock jointing pattern in the Genesee River and on the east gorge wall (opposite side of the river – Figure 4). Two sets of near vertical joints are evident, one approximately perpendicular to the river (estimated to be about N 55°W) and another approximately parallel to the river and alignment of the gorge walls.

***Figure 4 - Looking east across gorge at rock joint pattern***

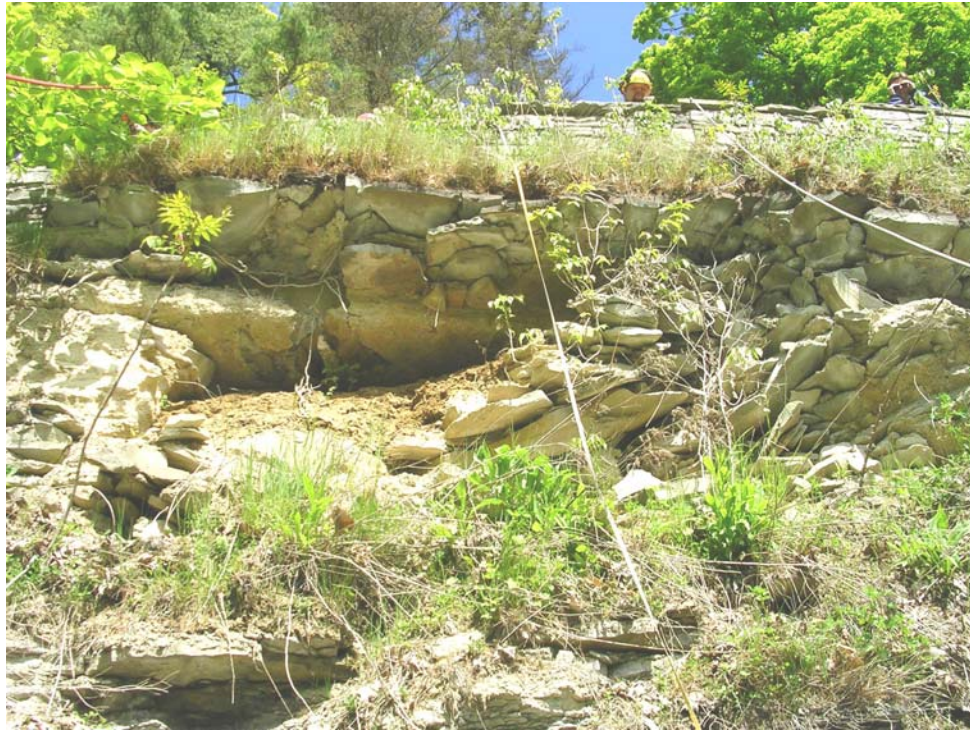
The area immediately beneath the road is not rock but is comprised of loose stones, soil and concrete. It appears that this area was a natural swale that workers who constructed the road filled in with stacked stones and concrete. Both the stones and concrete are disturbed and have fallen out of place for a distance of about 40 feet. A concrete grade beam could be seen spanning the area where stones have fallen out (Figure 5). Support had been lost for approximately 10 to 15 feet of the wall and road.

***Figure 5 – View (looking west) showing undermined area.***

The remedial design includes scaling loose rock from the face then installing shotcrete to fill the voids and stabilize the gorge face. The shotcrete facing is reinforced and is secured to the gorge face by rock nails. The nails are 1-inch diameter, Grade 95 kips per square inch, (ksi) reinforcing bars, drilled at least 6 feet into rock and grouted. Plastic pipes extend through the shotcrete to provide drainage and limit groundwater buildup behind the shotcrete.

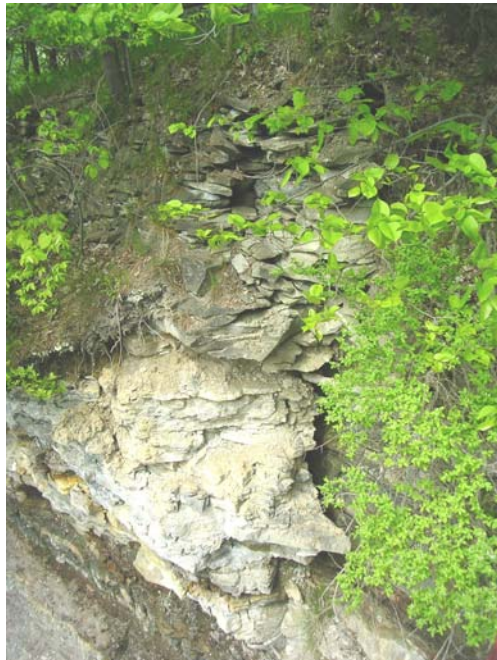
***Figure 6***

Two rock blocks or columns, one at each end of the approximate 40-foot disturbed section, were observed to be separating from the gorge wall (Figures 6 and 7).

The rock column at the south end (Figure 6) appeared to be separating from the gorge face along a nearly vertical joint parallel to the gorge face. The rock column at the north end of the disturbed area (Figure 7) appeared to also be separated along a near vertical joint but had moved laterally slightly less. Each column appeared to be composed of more competent rock at the bottom and loose rubble near the top.

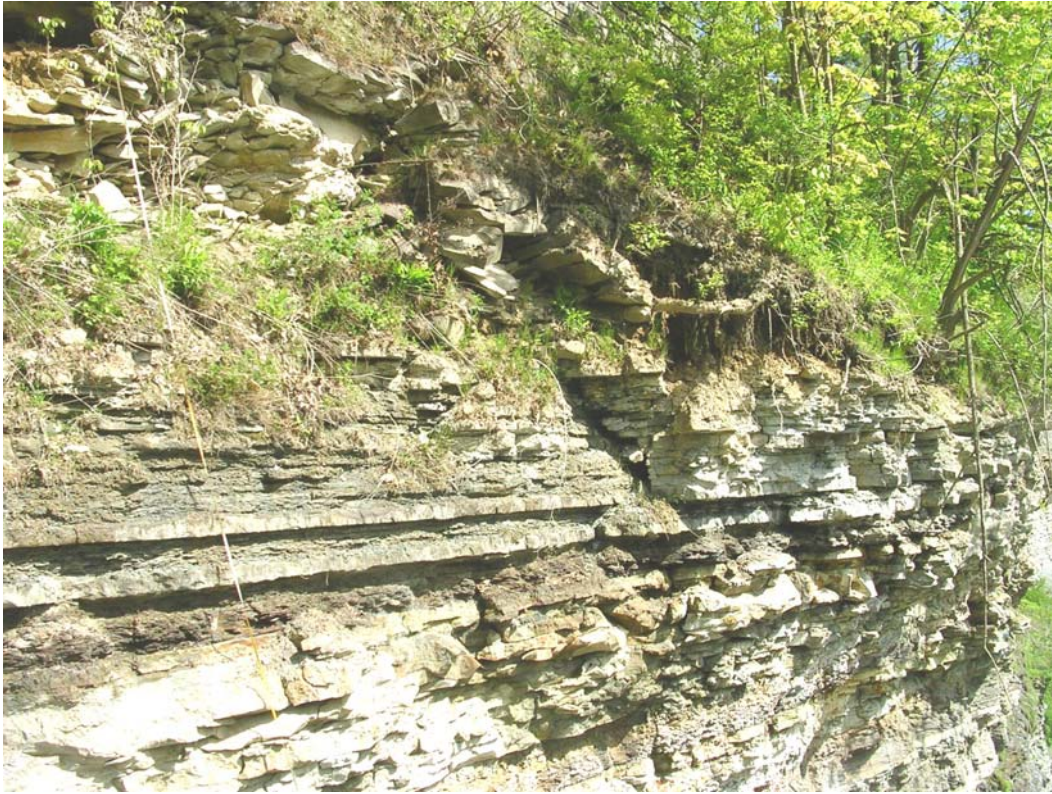
**Figure 7 - Rock Block on north side of undermined area separating from gorge face**

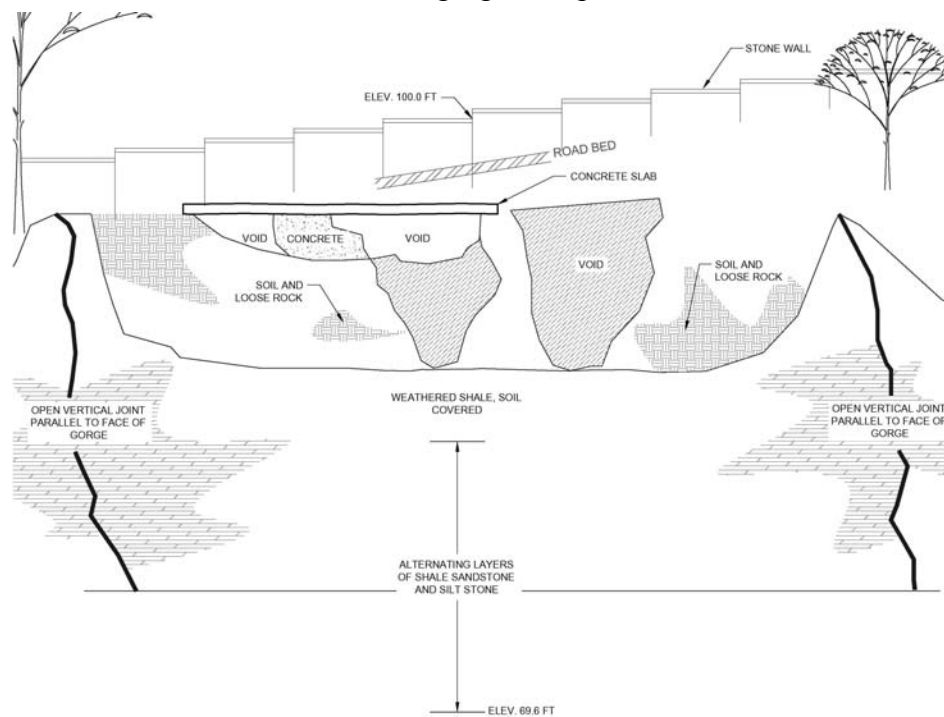
**Figure 8**

Figure 8 is a schematic elevation view of the gorge face prior to remediation.

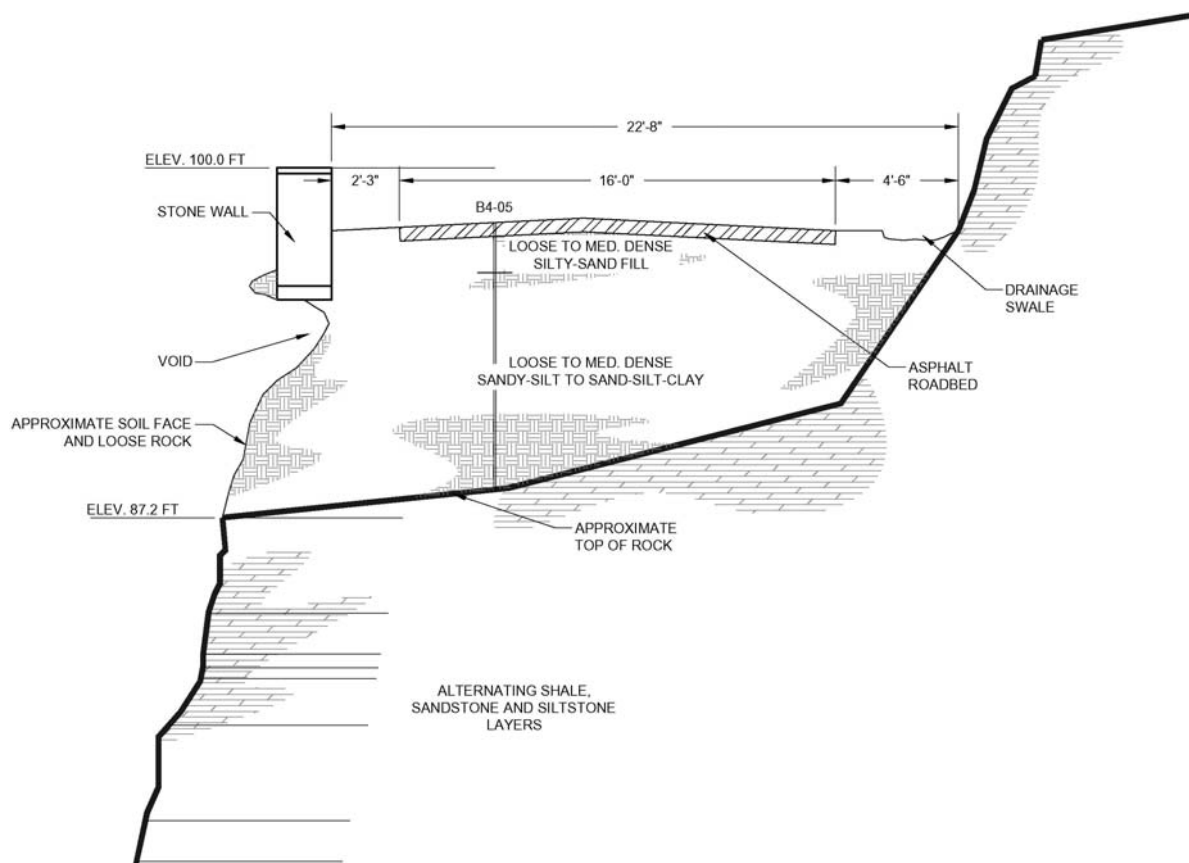
OPRHP closed the road to traffic and requested that MMCE and TVGA prepare plans to remediate the undermining. EDI drilled borings in the roadway to define the subsurface conditions. Figure 9 is a cross section of the road and gorge face based on our observations and the borings.

***Figure 9 – Typical Section Prior to Construction***

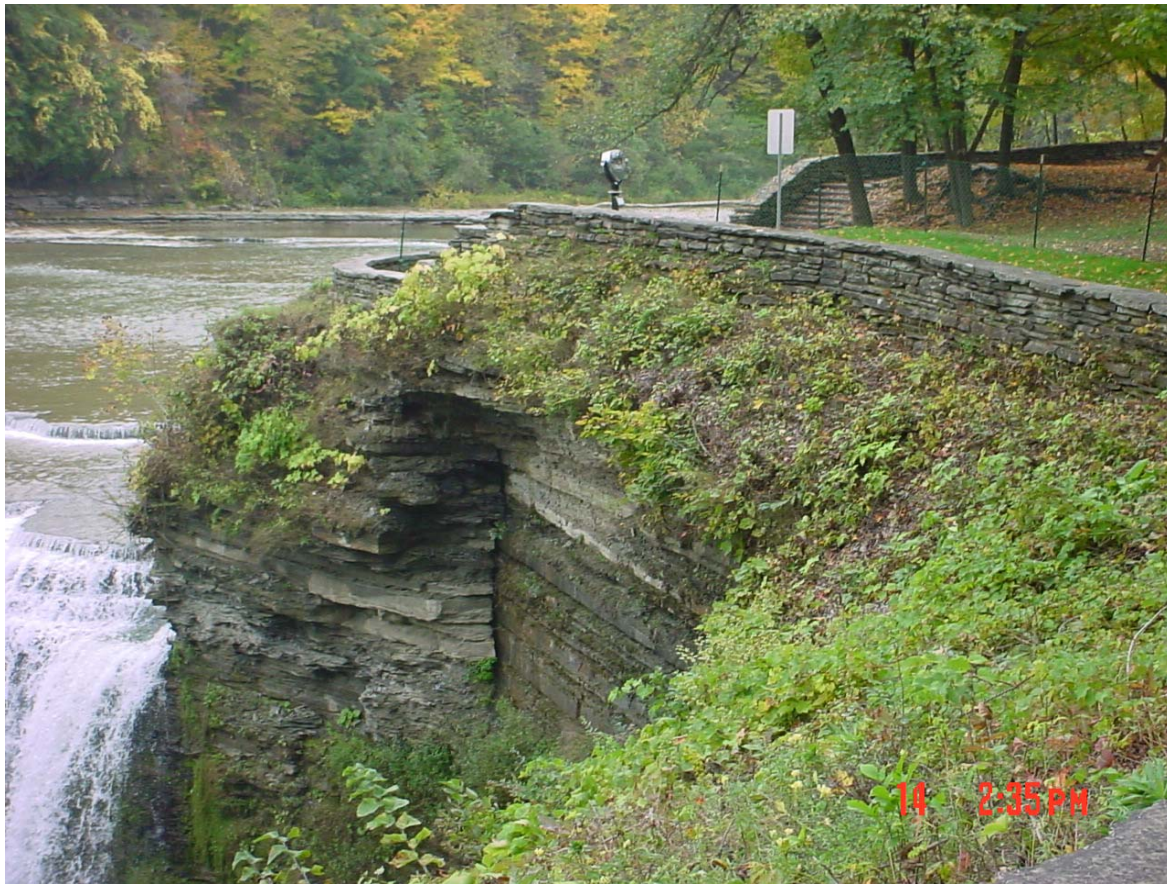
The Middle Falls at Letchworth State Park (see Figure 1 for location) offers dramatic views of the rock gorge and the Falls. OPRHP personnel requested that MMCE and EDI observe an area near the Middle Falls viewer platform requiring remediation. MMCE and EDI along with the Gorge Road contractor Janod, observed the conditions and found that loss of rock on the gorge walls and a large, block of rock at this location, separated from the gorge face by an open joint. The joint was also visible on the river side of the block. The open joint and loose rock is of concern relative to the stability of the overhang, which is a prominent location for pedestrians to view the Middle Falls (see Figure 15). This poses a significant safety threat to those viewing the Falls.

***Figure 15 – Middle Falls Prior to Construction – Note Open Joint***

The remedial design includes scaling and removing the overhang and removing loose rock from the gorge face. The design includes installing seven rock anchors in the rock block next to the Falls and eight rock anchors in the gorge face next to the rock block (i.e., the “overhang area”). Figure 16 is a schematic diagram of the design components.

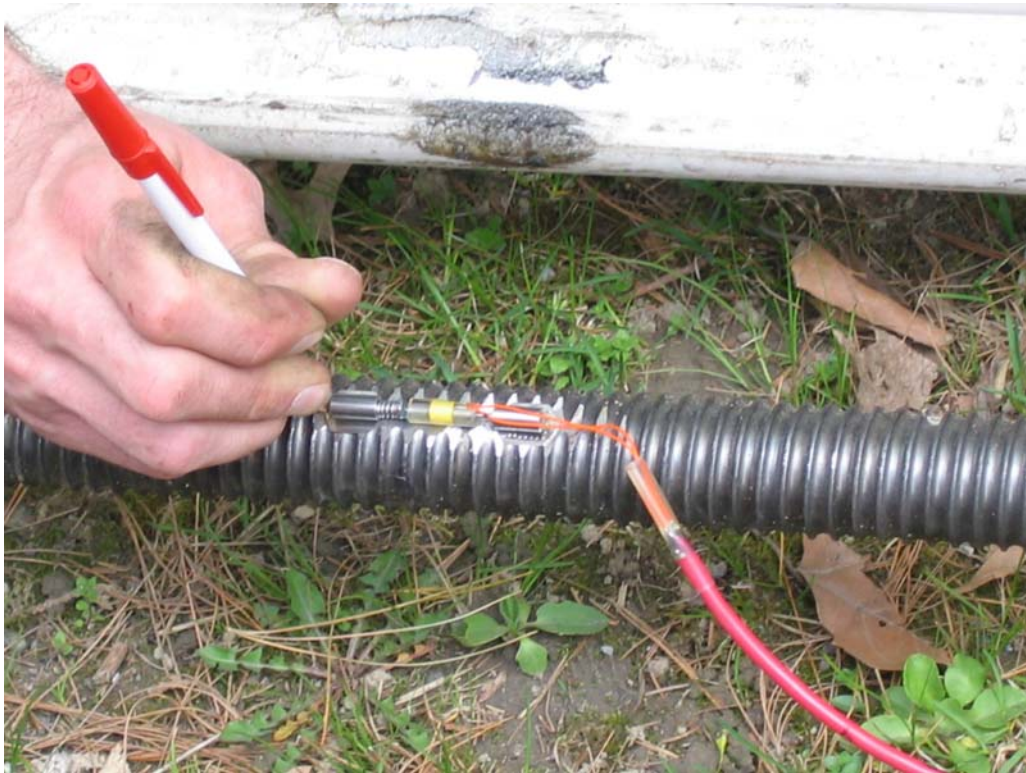
Wires from the strain gauges lead to a central readout box installed into the newly construction portion of the viewing platform wall. MMCE has monitored the gauges since construction was completed. The data do not indicate an increase in stress in the anchors.

Strain gauges were installed on several rock anchors to provide a means of monitoring stress in the anchor rods and rock movement. Figure 23 shows a typical strain gauge installation.

***Figure 23 Strain Gauge Installation***
