Difficult Geologic Conditions Mandate Retaining Wall Redesign

Donald R. McMahon, P.E., M.ASCE¹, Andrew J. Nichols, P.E., M.ASCE¹ and Brian T. Contino, P.E.²

ABSTRACT

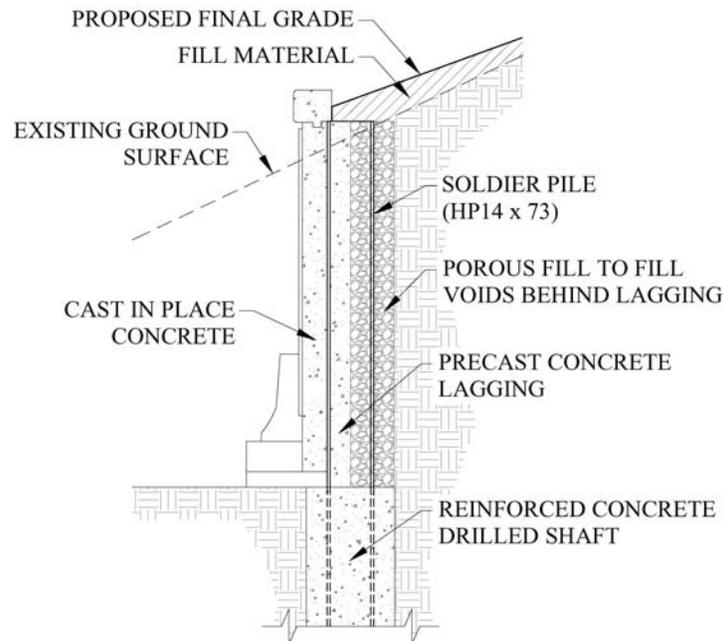
The site topography can be described as rolling. Within the limits of RW-8, the highway grade rises gently to the north, but the ground on the outside of the pavement slopes upward about 20 to 25 feet. Thus, the highway widening required a wall to maintain a manageable slope outside the highway limits. Figure 1 shows a section view of the proposed top-down wall and the ground surface conditions.

Figure 1. Top-down retaining wall section.

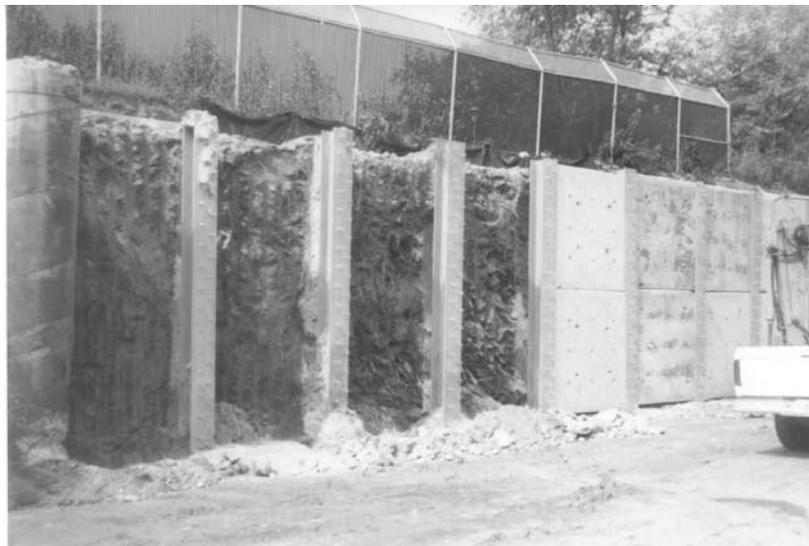
The contractor had successfully completed drilling some excavations for the soldier piles and had placed them in the drilled excavations. It excavated the sloped soil in front of the soldier piles, extending the excavation with an unsupported vertical face to the back flange of the soldier piles, as shown in Figure 2 to allow installation of the concrete lagging between the soldier piles and drainage material behind the lagging. These excavations allowed an indirect measure of the soil undrained shear strength.

In two locations along the RW-8 alignment, the contractor had left excavations between the soldier piles for the lagging (similar to the conditions shown in Figure 2) open for several weeks before installing the lagging. The excavations appeared stable and the ground surface at the top of the excavations showed no indication of lateral movement, such as tension cracks or sloughing. The excavation height was 16.5 feet.

Figure 2. Top-down wall before lagging installation.

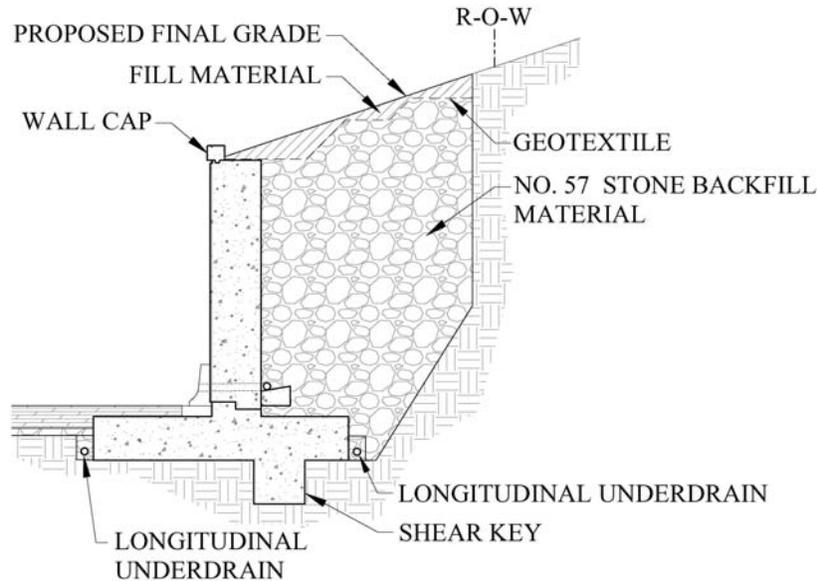
Figure 3. Alternative retaining wall section.

The designers elected to include a shear key to assist with sliding resistance and specified a uniformly graded crushed stone for backfill. This material was estimated to have an angle of internal friction of 38 degrees and an estimated unit weight of 100 pounds per cubic foot, Alva (1981). This friction angle placed a majority of the theoretical failure plane within the backfill. The high friction angle and low unit

weight also reduced the lateral forces on the wall. Figure 3 shows a typical section of the alternative wall.

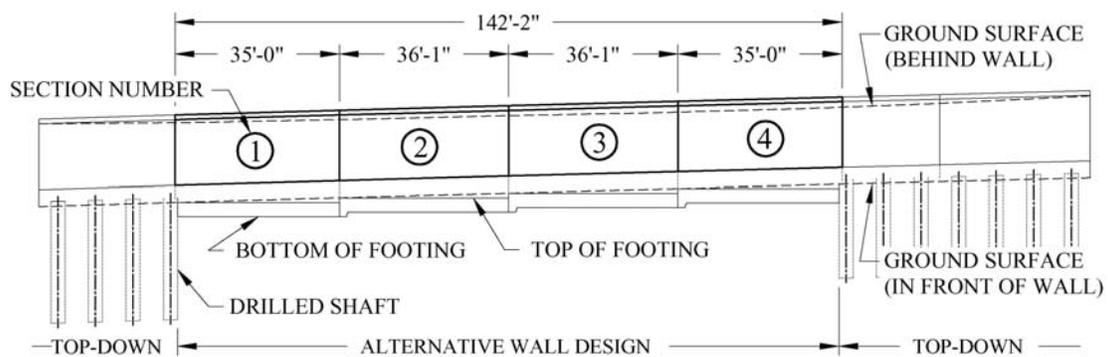
Figure 4. Alternative wall profile.

Although the estimates of the soil shear strength indicated that the excavation slopes would remain stable for the duration of construction, the designers elected to divide the length of the cast-in-place wall into four approximately 35-foot sections for construction. The first section was excavated and the wall was built and backfilled before the adjacent wall section excavation was begun to take advantage of any soil arching that might exist between the wall sections to assist in maintaining the vertical slope stable. The construction sequence (see Figure 4) was:

- Excavate and build Section 1 (southernmost section)
- Excavate and build Section 3
- Excavate and build Section 2
- Excavate and build Section 4

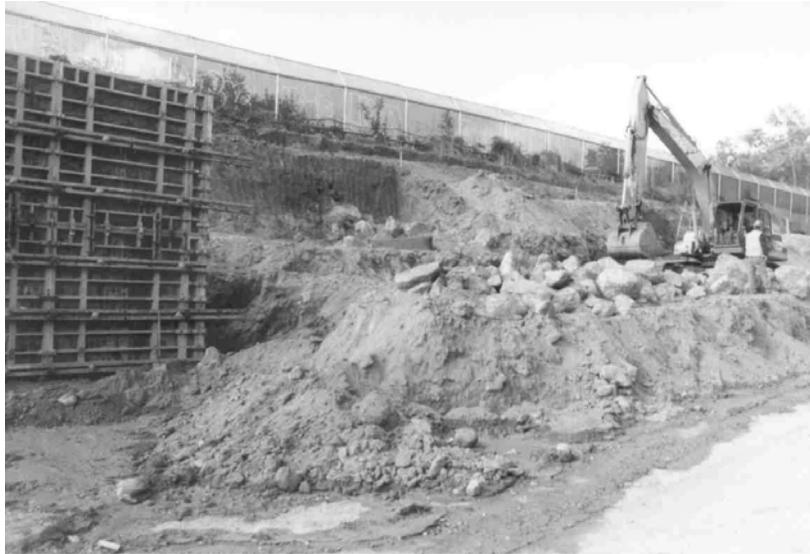
Figure 5 shows the excavation of Section 1 in progress and the boulders removed from the excavation. This amount of boulders was the cause for the drilling difficulties.

Figure 5. Excavation of Section 1.
