Stream Bank Remediation; Not Just a Geotechnical Problem

Todd Swackhamer¹, P.E., M. ASCE, James J. Janora², A.M. ASCE, David Derrick³

This paper presents two case histories that illustrate the geotechnical and geomorphic causes of slope failures along streams. For one case history, geotechnical issues, such as weak soils, steep slopes, high groundwater levels, and poor drainage, are the predominant causes of the slope instability. For the second case history, stream dynamics, particularly erosion of the slope's toe, caused the slopes to fail. The case histories illustrate how remedial methods are developed to address both the geotechnical and geomorphic issues. This includes traditional methods to improve geotechnical conditions and some non-traditional methods such as using the dry-mix method to improve the strength of soft sensitive clay soil. Remedial methods to address the stream conditions include measures such as river training, bank armoring, and revegetation.

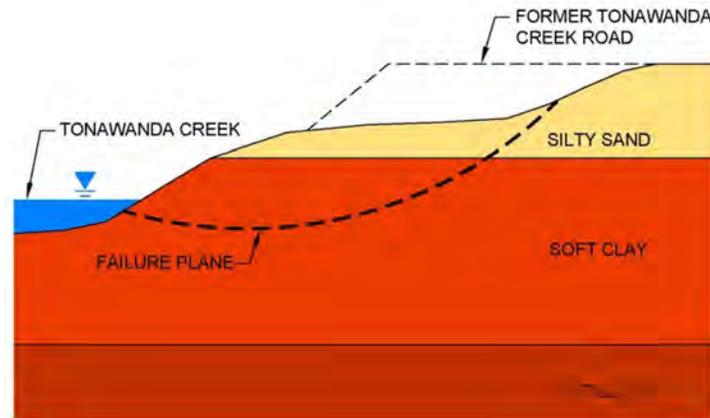
A subsurface exploration program, which included soil sampling, instrumentation (monitoring wells and inclinometers), and in-situ and laboratory testing, indicated that, prior to the failure, the slope was supported by soft silt and clay deposits (see Figure 2). The clay deposits extend approximately 35 feet deep to a till layer and have undrained shear strengths between 200 and 600 pounds per square foot.

Combining the geotechnical study with the scale variant approach helped the engineer understand the causes of failure. The upper silty sand zone became saturated due to precipitation and poor drainage. Scour at the outside bend removed the bank's toe support. The combination of a heavy, saturated bank, soft silty clay support, and reduced support along the toe eventually caused the bank to fail along a rotational plane.

Figure 2 – Simplified subsurface profile at Tonawanda Creek Road failure

The engineers elected to remediate the slope failure by addressing the geotechnical and hydraulic factors that contributed to the problem. First, the slopes were stabilized by improving the drainage of the silty deposits above the soft zone. This lowered the driving forces on the slope by removing weight. Second, the engineers increased the shear strength of the soft silt and clay deposits using a dry soil mix method. Third, longitudinal stone fill and vegetation were placed along the bank's toe to address future erosion.

The stability analyses showed that improving drainage and lowering the groundwater level was not enough to provide an acceptable factor of safety for the remediated slope. The soft silt and clay deposit did not have enough shear strength to resist the driving forces. As such, the engineers elected to improve the shear strength of the soft deposits using soil cement columns constructed using a dry soil mix method.

At this site, the design required over 2,200 30-inch diameter columns that extended approximately 35 feet deep to the bottom of the soft deposits. The columns were treated with approximately 125 pounds of cement per cubic yard of treated soil. Laboratory and field tests showed the improved composite undrained shear strength (a weighted strength considering the columns and the remaining soft deposits) to be between 2,000 and 3,000 pounds per square foot.

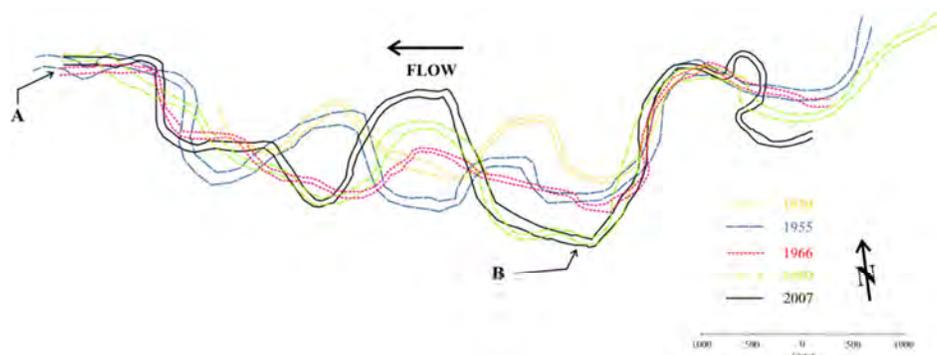
Figure 3 - Time lapse overview of Cattaraugus Creek; Arrow at A indicates the location of a bridge over the river, Arrow at B indicates the location of the site.

Sometime between 1966 and 1980, Cattaraugus Creek at the Creek Road site meandered south until it encountered the valley wall near Creek Road. A sheetpile wall was constructed in an attempt to protect the roadway, but over time the toe of the wall was undermined and the wall rotated into the channel. Migration toward the roadway continued until erosion reached the shoulder of Creek Road.

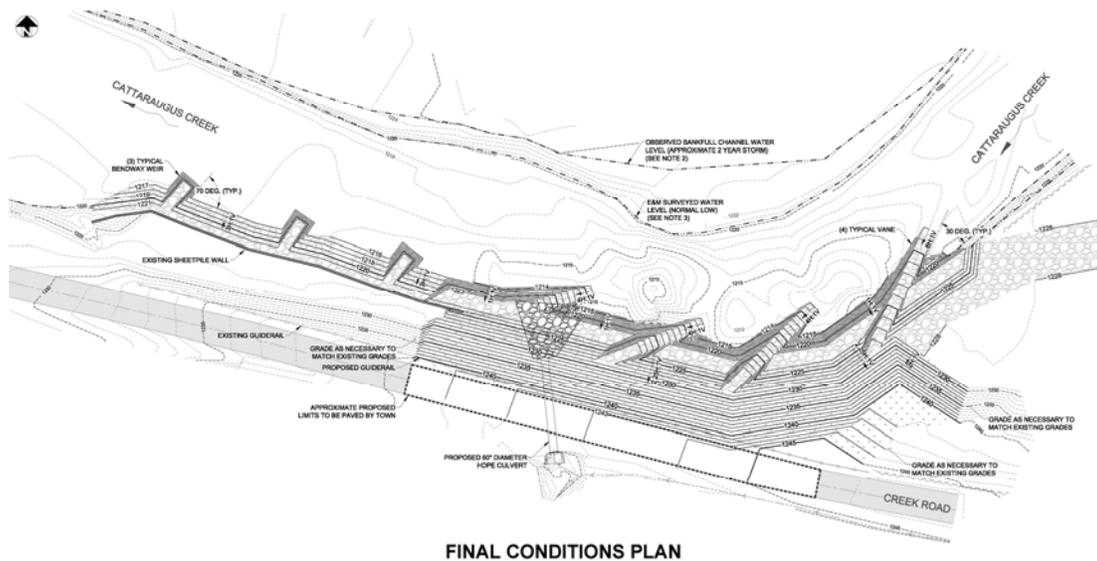
Once the causes of the slope instability were understood, the engineer developed a plan to mitigate the bank by improving slope drainage, river training, and providing erosion protection. Figure 4 shows the remediation plan at Creek Road.

Figure 4 – Remediation plan at Creek Road

A series of rock vanes and bendway weirs were constructed to redirect the thalweg away from the bank. One vane was placed immediately upstream of the bend, three vanes were placed in the bend, and three bendway weirs were placed downstream of the bend. The intention was to use the vanes to guide the thalweg around the bend while maintaining the thalweg away from the bank, and then use the bendway weirs to direct the thalweg toward the center of the channel as it exits the site. The vanes were extended one foot above the bankfull flow elevation and the bendway weirs were extended two feet above the base flow elevation.

Riprap was placed along the streambank above the longitudinal stone toe to reduce soil erosion. The design called for extending the riprap from the toe of the slope up to the estimated elevation of the 10-year recurrence interval flood elevation. Vegetation was established above the elevation of the riprap to protect the soil from intense precipitation and from extreme high flows. Temporary erosion mat was installed to protect the soil between the time construction was completed and the time a dense stand of vegetation was established.

An upstream key was extended back into the floodplain terrace to an area of existing dense vegetation to prevent the channel from migrating and eroding behind the revetment and protection works. The upstream key was excavated as deep as the invert of the channel and the riprap was extended up to one foot above the bankfull elevation.

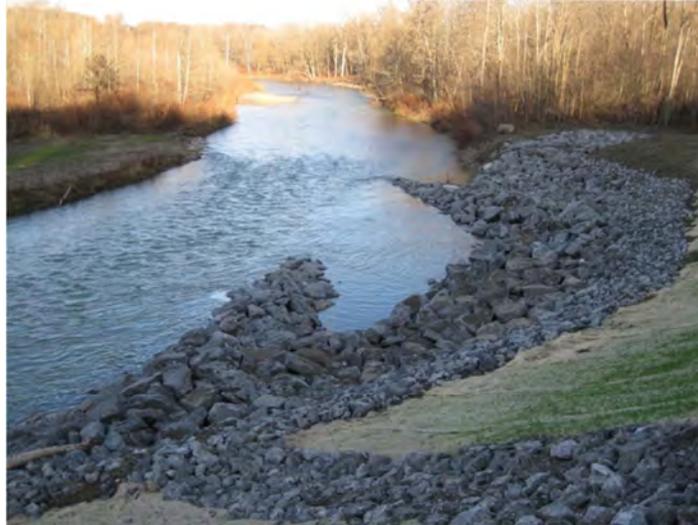
Figure 5 – Note the thalweg location off the river-end of the rock vanes
