## PROJECT DESCRIPTION

### *Tonawanda Creek at West Phalinger Road – Slope Failure*

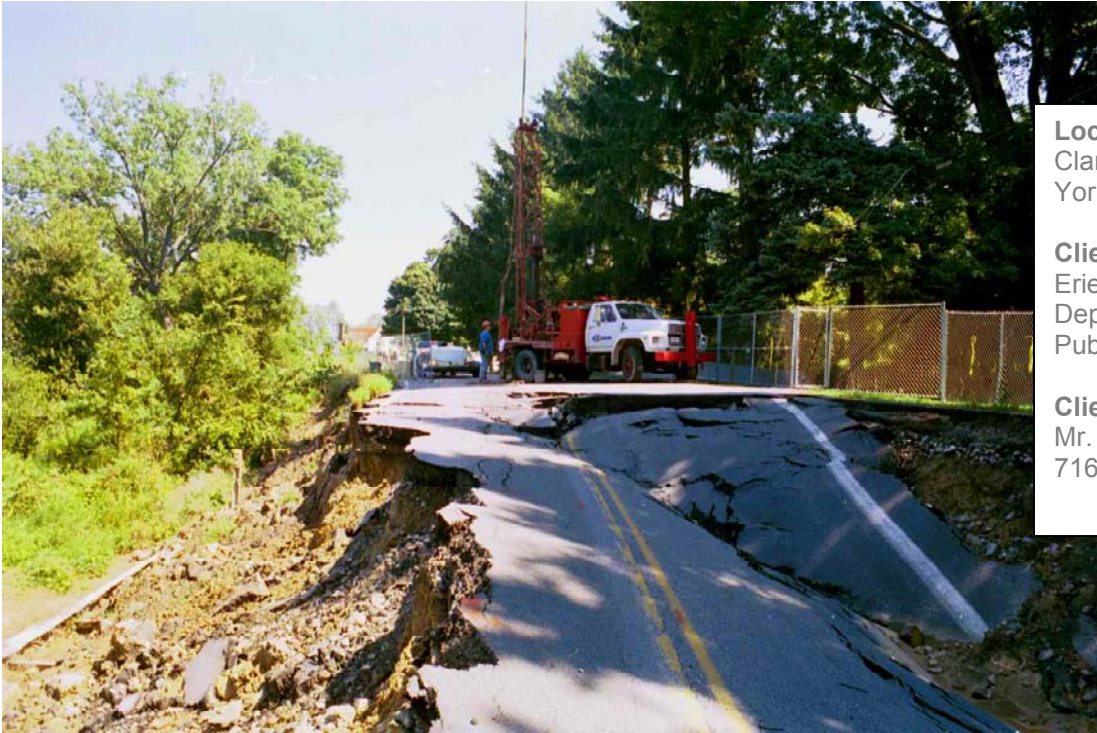
#### ***View of Slope Failure Looking East***

A slope failure along Tonawanda Creek has damaged a portion of Tonawanda Creek Road between Transit Road and West Phalinger Road in the Town of Clarence. A section of Tonawanda Creek Road, approximately 250 feet long has dropped about 10 feet and pushed soil into Tonawanda Creek. The failure area has continued to expand laterally, encompassing more of the road since it was discovered on June 25, 2004.

MMCE made test borings, installed an inclinometer and piezometer and measured the in-situ strength of the soft clay soil that extends to 35 feet below the road. MMCE used this information to evaluate the feasibility of various approaches to remediate the conditions.

Remedial options include mixing dry cement into the clay soil using the dry mix method to stabilize the soft clay soils beneath the road. The remedial design includes stream restoration techniques to protect the stabilized road embankment using a combination of rock riprap and vegetative measures.
