## PROJECT DESCRIPTION

### *Lake Bonita Dam*

**Location:**  
Wilton, New York

**Client:**  
NYS Office of  
General Services.

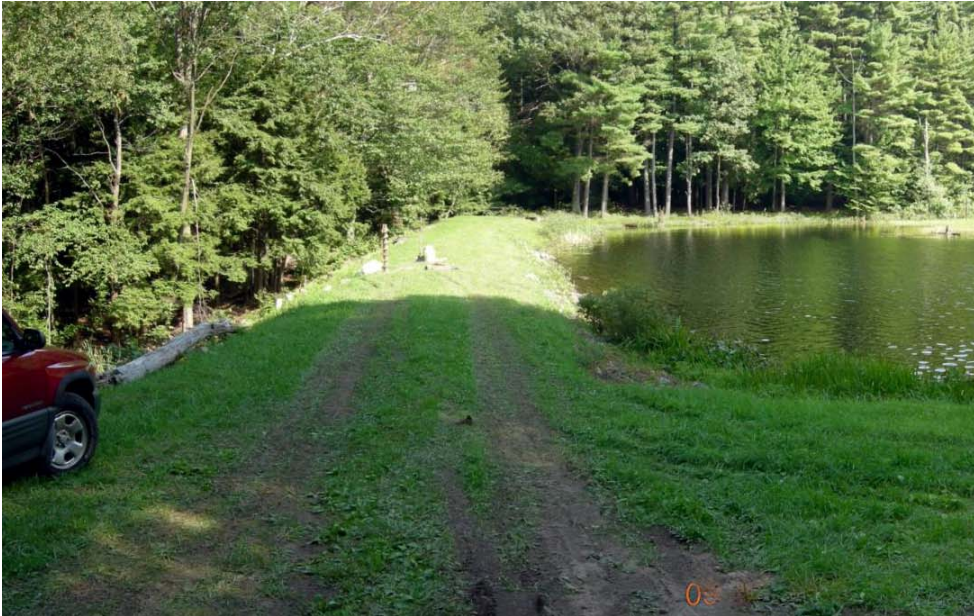
***North end of Lake Bonita at the dam***

Lake Bonita is located on the Mount McGregor Correctional Facility property in Wilton, New York. The 60-acre lake is retained by an earthen dam, located at its northern end. The lake serves as a water supply for the Correctional Facility and forms the headwaters of Beaver Brook, which begins at the dam and flows from south to north towards its confluence with Stony Brook. Water flows from Lake Bonita, over a concrete ogee spillway at the east end of the dam into the creek.
