PROJECT DESCRIPTION

Schoellkopf Wall Evaluation

Niagara Falls, New York

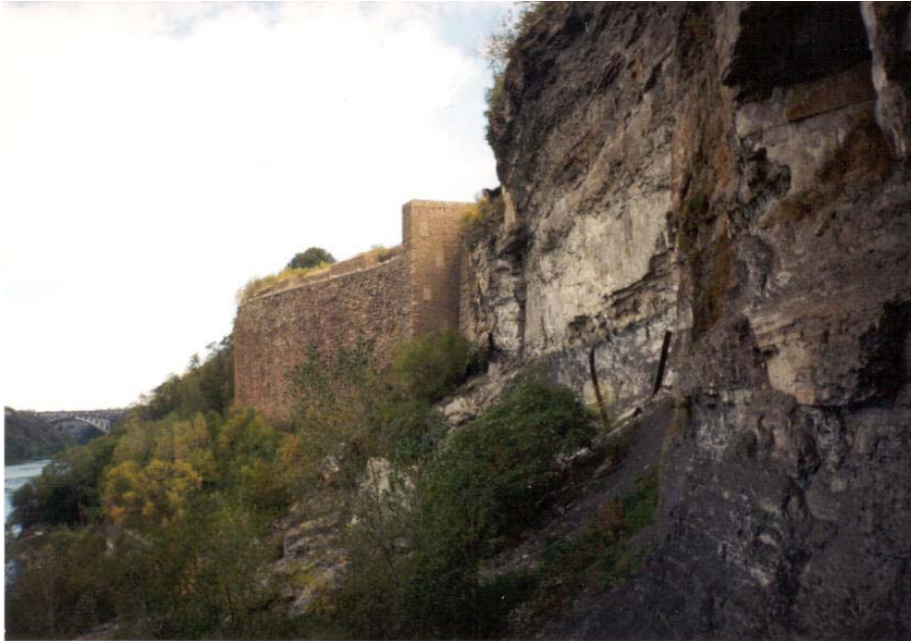
View of Schoellkopf Wall and Niagara Gorge Looking North

A masonry wall, about 100 feet high, is all that remains of the former Schoellkopf Power Plant. The plant collapsed suddenly over 40 years ago from a rock slide next to the plant. The New York State OPRHP operates the property and is evaluating the feasibility of opening the top of the wall as an observatory for the adjacent Niagara Gorge. MMCE assisted in this evaluation by:
