# UNDERPINNING A CRANE FOUNDATION

Donald R. McMahon, P.E., McMahon & Mann Consulting Engineers, P.C., Buffalo, New York, USA

This paper presents a unique case history that documents the use of a braced secant pile wall to underpin a heavily loaded footing inside of a manufacturing plant. Construction of a pit for a new manufacturing process directly next to the footing necessitated the underpinning. The footing supports an overhead crane that needed to remain operational throughout construction of the pit and therefore, settlement of the footing could not be tolerated. The base of the footing was about 7.7 feet above the base of the 17-foot deep excavation.

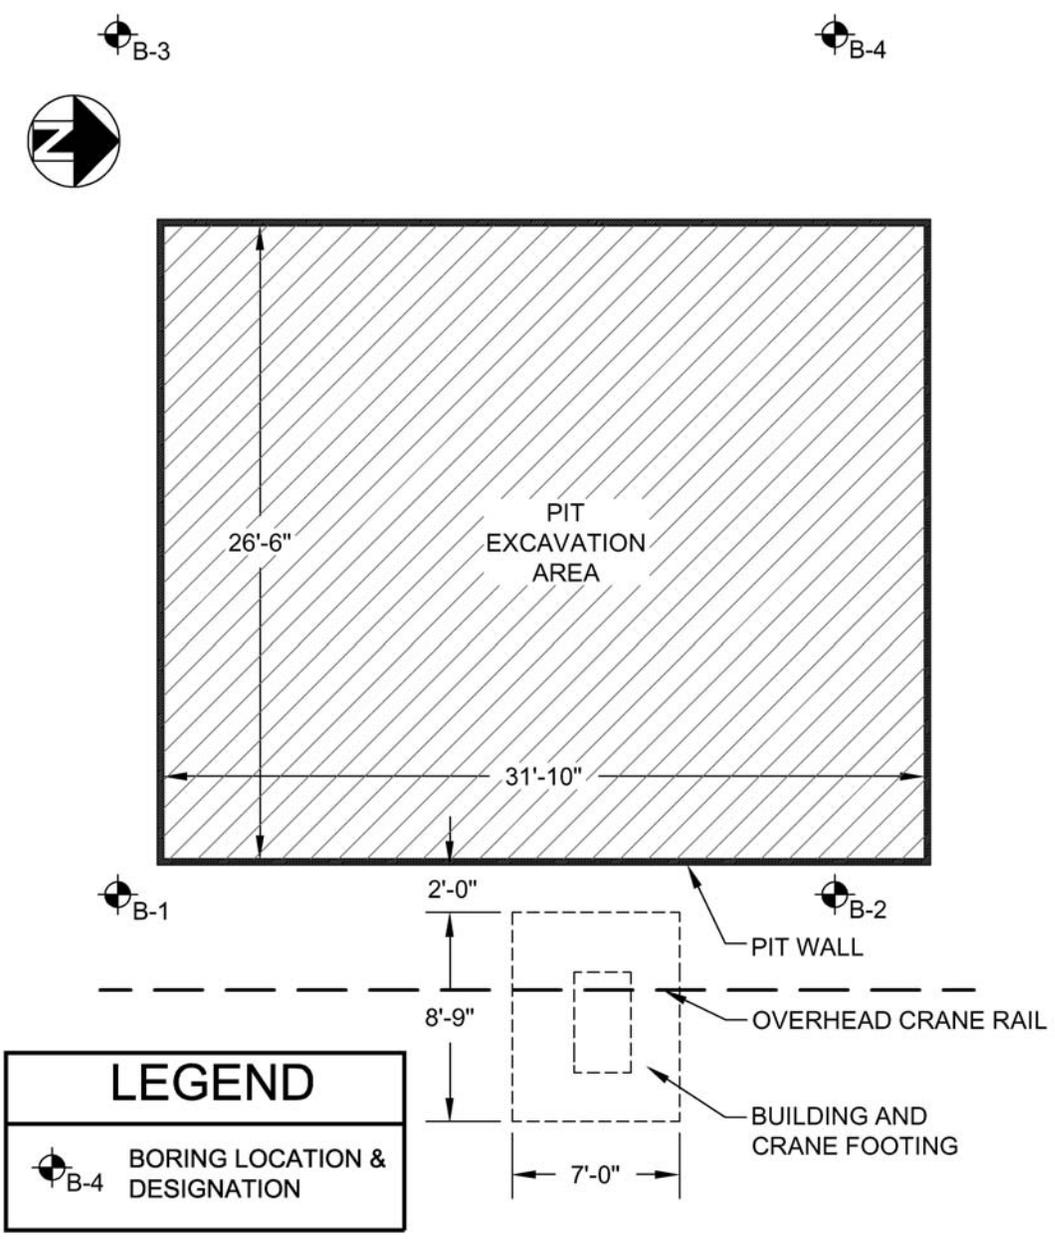
**Figure 1:** Plan view showing the footing, crane rail and pit

A manufacturing plant in Buffalo, New York planned to construct a pit for a new hot strip mill inside one of its buildings as part of a plant improvement project. Construction plans for the pit showed it having reinforced concrete walls and floor with interior dimensions of 32 feet wide by 27 feet long. The floor of the pit has two levels, one requiring a 12-foot deep excavation and the other requiring a 17-foot deep excavation. The part of the pit with the 17-foot depth is directly next to a spread footing that supports the building roof, building wall and a 40-ton overhead crane. The footing has plan dimensions of 7 feet along the edge of the pit by 9 feet. Project drawings show the edge of the

footing 24 inches from the outside wall of the pit. The excavation for the pit was planned to extend to 7.7 feet below the base of the footing, which is 9.3 feet below the plant floor. The excavation included a precut to the top of the footing and the remainder of the pit excavation needed shoring to underpin the footing.

Figure 1 shows the location of the pit in relation to the spread footing and Figure 2 shows a section view of the pit next to the footing. The plant required the use of the overhead crane throughout the pit construction. The estimated footing contact pressure is 3000 pounds per square foot. The project required the contractor to design and install shoring for the excavation.

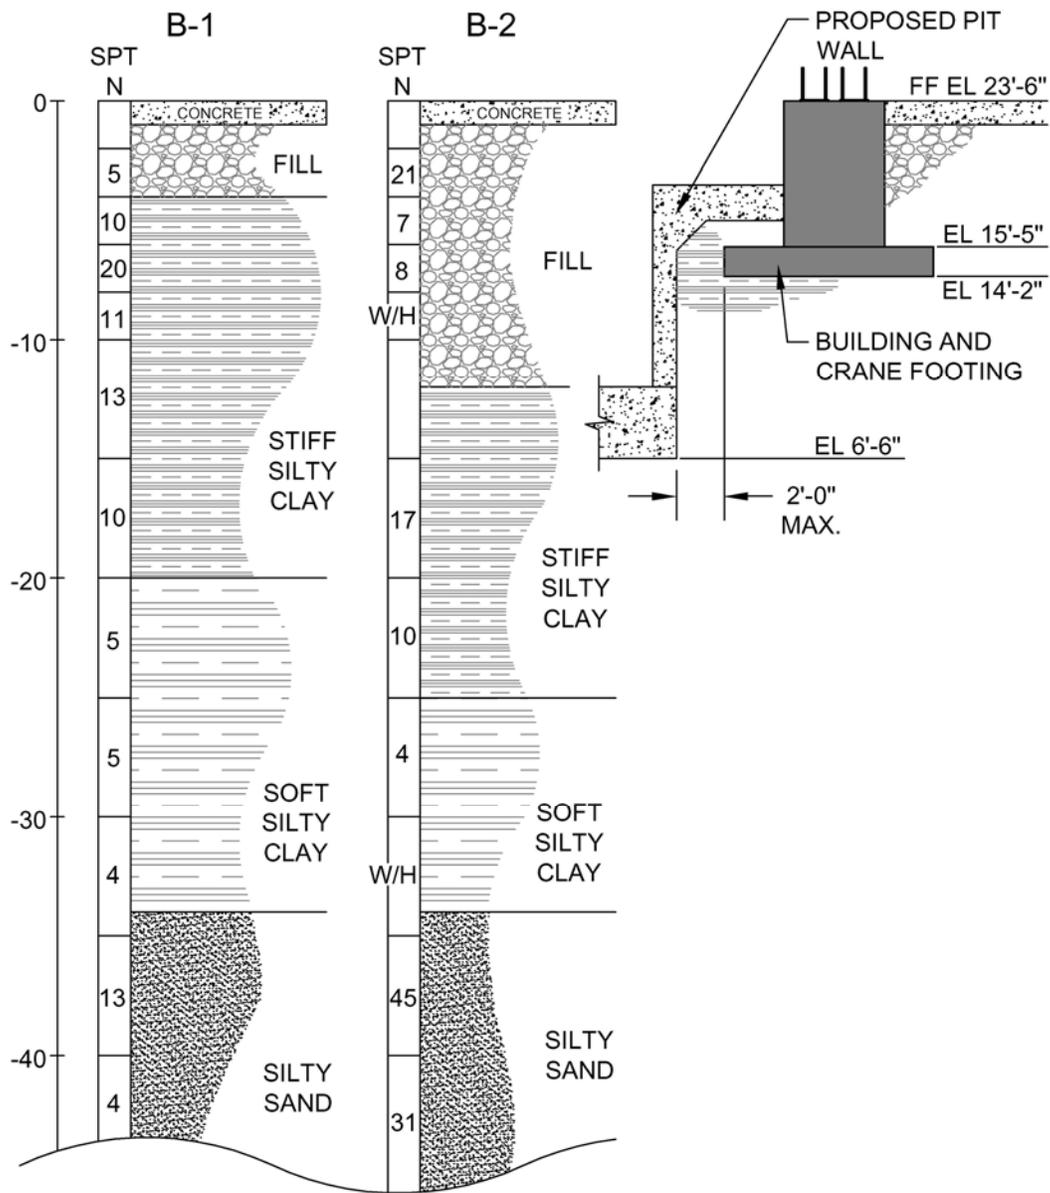
**Figure 2:** Section through footing and pit wall with subsurface conditions

The plant is located in a former glacial lakebed. The results of four borings made near the pit corners show a silty clay deposit underlying a thin layer of recently placed fill. The consistency of the silty clay ranges from stiff near its surface to soft to medium near the base of the pit excavation. A loose to dense silty sand layer underlies the silty clay, about 34 feet below the plant floor. The ground water level was estimated to be near the transition from the stiff clay to the medium clay about 20 feet below the plant floor. Figure 2 shows the soil sequence from borings drilled near the footing.

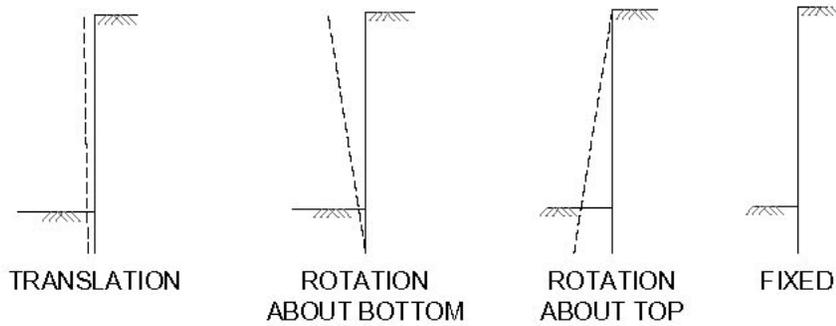
**Figure 3:** Deformation modes for a rigid wall, Goldberg et al. (1976)

The design of any retaining wall where deflection is a design criterion needs to consider potential deflection modes of the wall. Goldberg et al. (1976) presents modes of deflection for two wall types, a rigid wall and a flexible wall. A rigid wall can rotate about the top, rotate about the tip or translate, as shown in Figure 3. A flexible wall also experiences these deformation modes, but also can bulge in the mid-span, as shown in Figure 4.

Figure 3 shows the deformation mode of a cantilever wall, i.e., the rotation about the toe. This was expected to contribute unacceptable deformations and therefore the top of the wall needed to be supported by either an internal brace or a tieback extended beneath the footing.

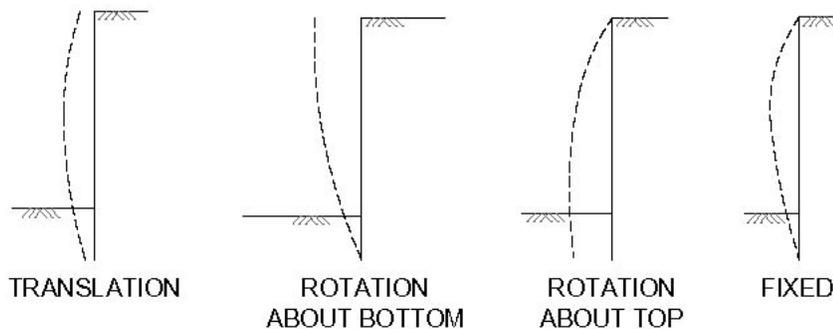
**Figure 4:** Deformation modes for a flexible wall, Goldberg et al. (1976)

The last deformation mode to be addressed is bulging, see Figure 4. This could occur if the wall was too flexible for the loads applied.

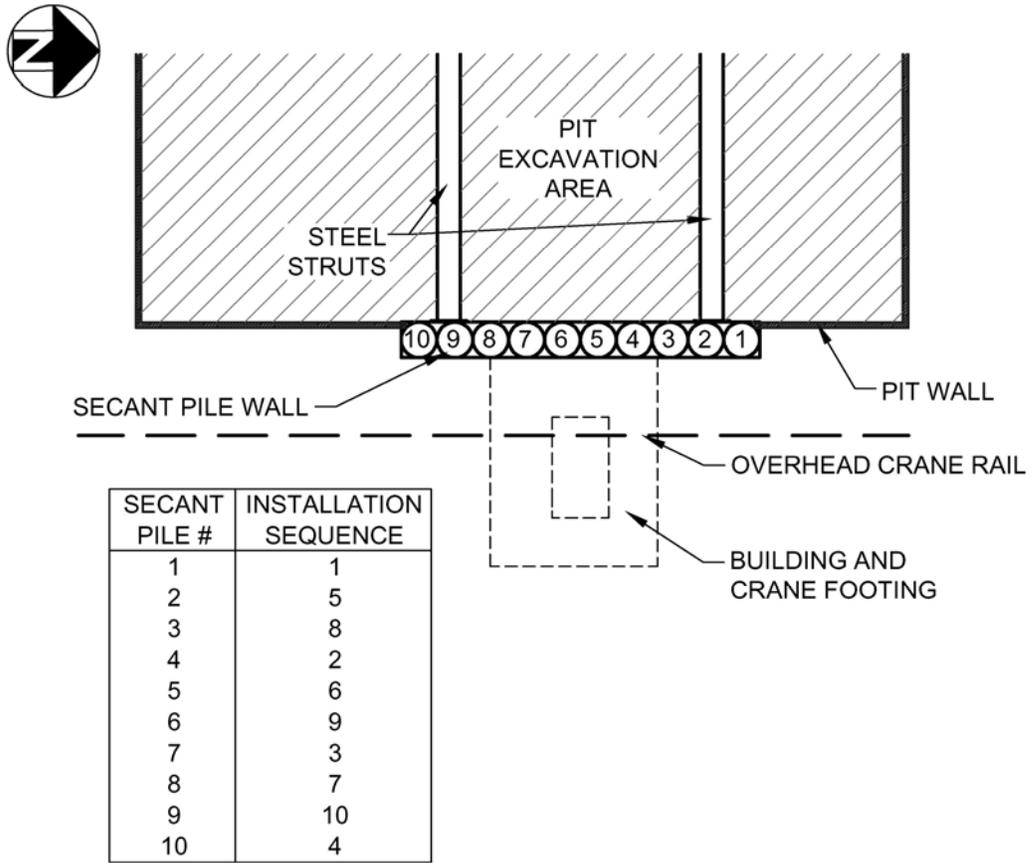
**Figure 5:** Plan of secant pile wall

Figure 5 shows the secant pile wall in plan and Figure 6 shows a section through the wall.

The secant pile wall consisted of ten, 18-inch diameter drilled shaft excavations. The contractor drilled every third secant pile on the first pass to limit the potential for soil deformation beneath the footing. This allowed the concrete to develop an initial set before beginning the second pass. Figure 5 shows the construction sequence. The secant piles were excavated without casing. The contractor used a concrete mix that produced an unconfined compressive strength of 3000 pounds per square inch in three days to allow the piles to develop sufficient strength to allow drilling directly next to it.

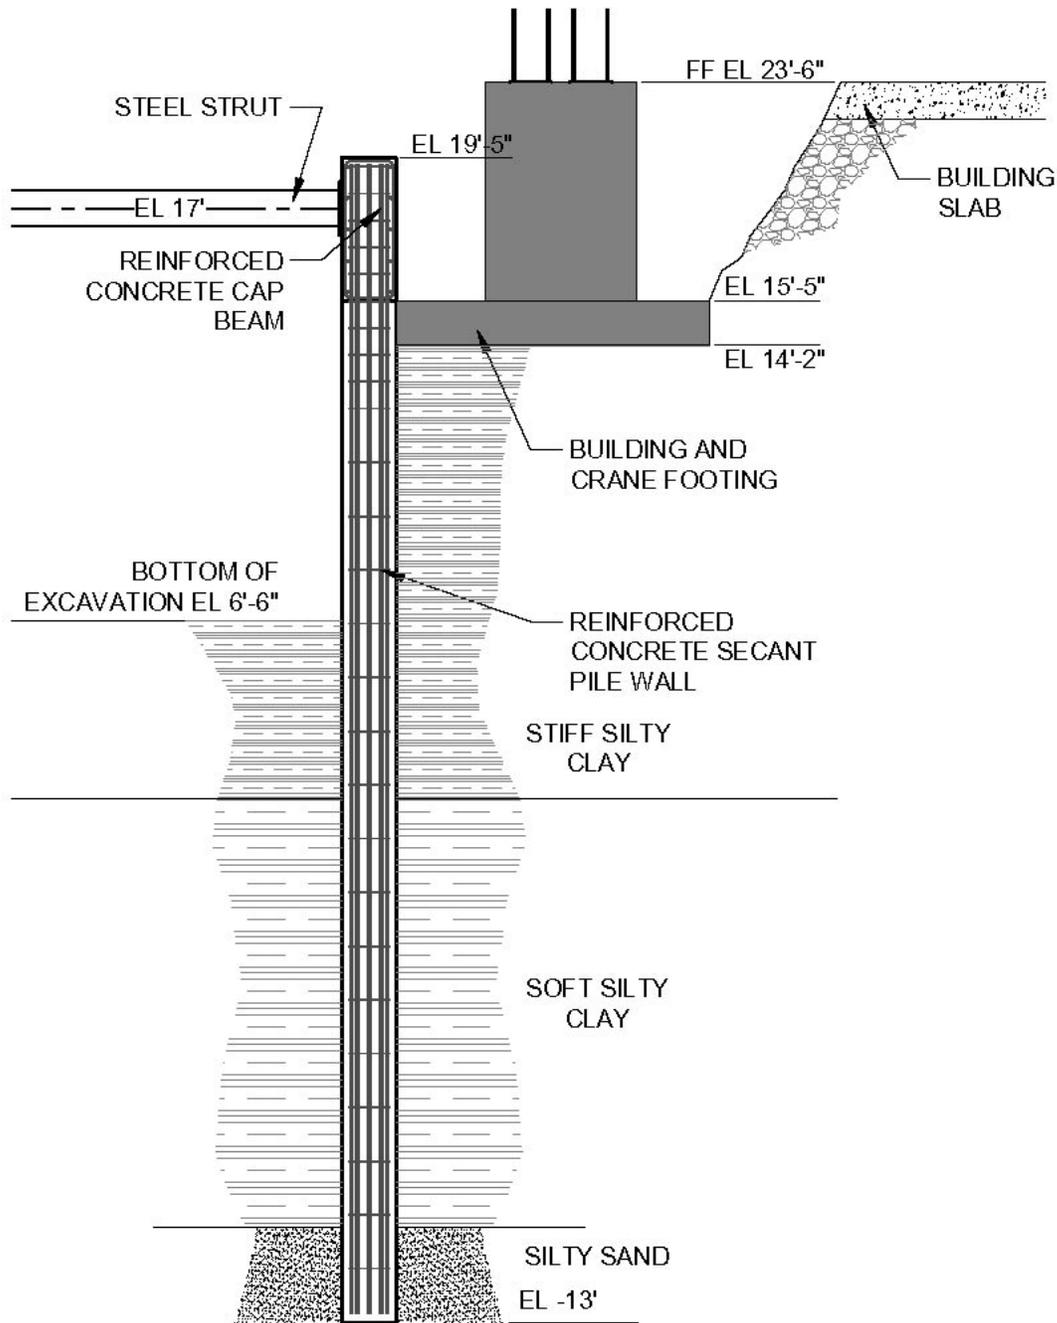
**Figure 6:** Section through secant pile wall

Figure 6 shows the wall extending 3 feet into the underlying silty sand deposit. This is necessary to address three design issues.

1. The factor of safety against basal heave is low and extending the wall into a firm

stratum improves the factor of safety against basal heave.

2. The silty sand deposit provides resistance for moment equilibrium of the wall about the brace because resistance

contributed by the soft to medium silty clay is insufficient.

3. The silty sand provides a "fixed end" condition for restricting wall translation and rotation about the brace.

The contractor began this project by excavating the fill over the top of the footing, as shown on

Figure 6. This reduced the lateral load applied to the wall and allowed the contractor to identify the edge of the footing along the pit. Once the edge of the footing was exposed, the contractor could establish the edge of the secant pile wall so that the wall could be constructed abutting the footing.

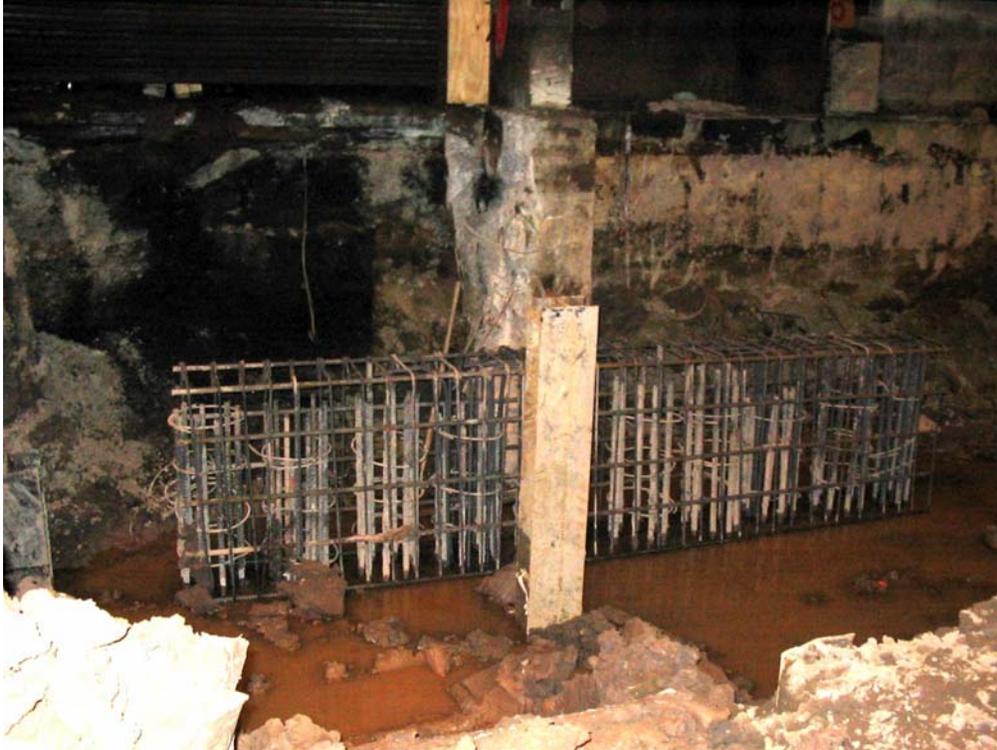
**Figure 7:** Cap beam reinforcing steel

Once the drilled shafts had been completed with the reinforcing steel extending from the top of

the shafts, the cap beam was formed and placed. The pit excavation had yet to extend below the top of the footing, see Figure 7.

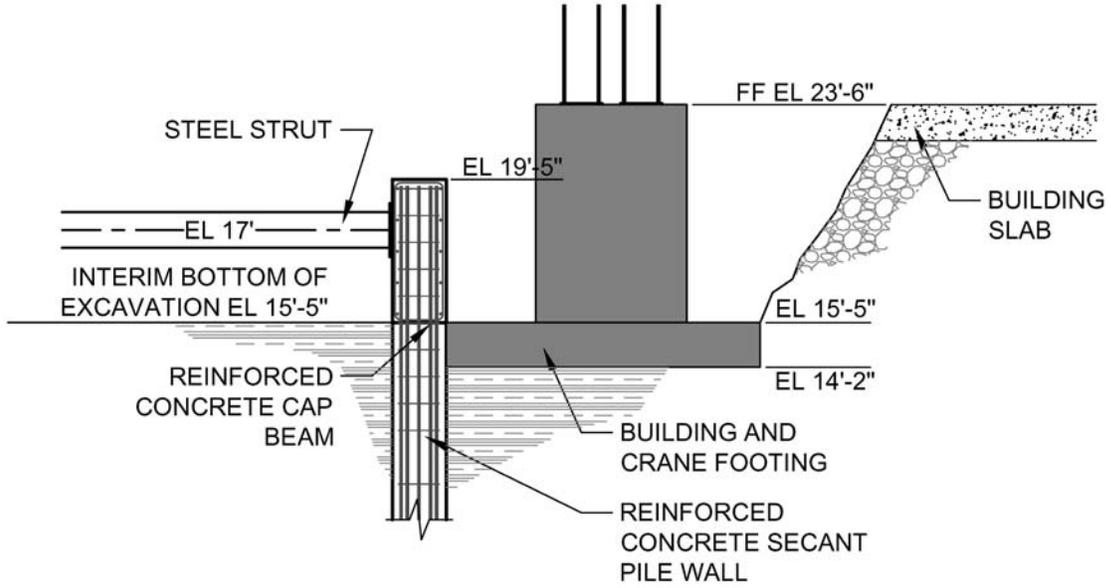
**Figure 8:** Section through secant pile wall prior to excavation

The soldier piles for the remainder of the pit excavation were installed next and two horizontal struts were placed against the cap beam and spanned across the excavation to the

wale on the opposite side of the excavation. The bracing scheme, shown on Figure 8, was completed before the contractor extended the excavation below the top of the footing. The struts were shimmed tight against the wale.

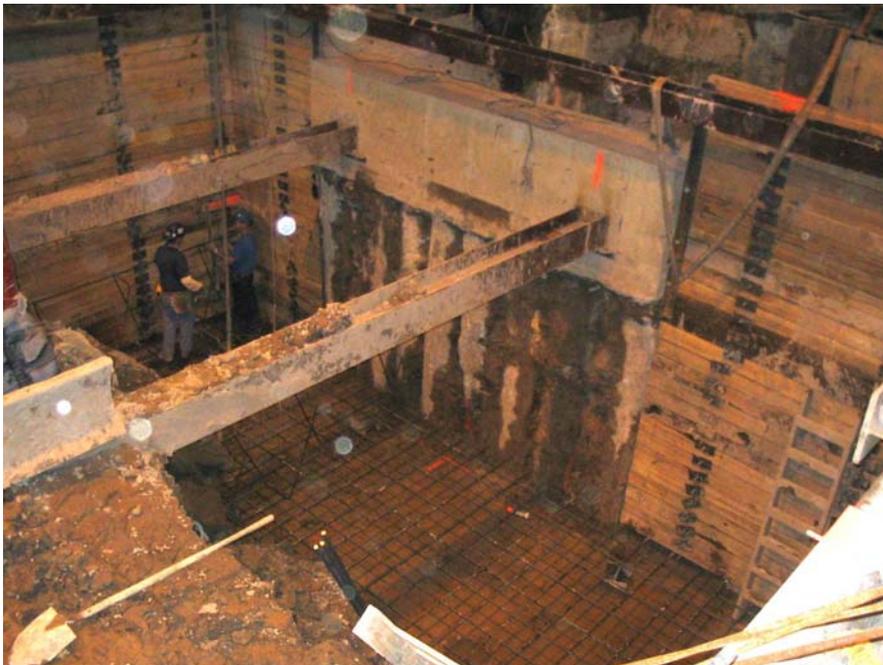
**Figure 9:** Completed secant pile wall and bracing

Figure 9 shows the completed secant pile wall with the cap beam and struts in place. Figure 10

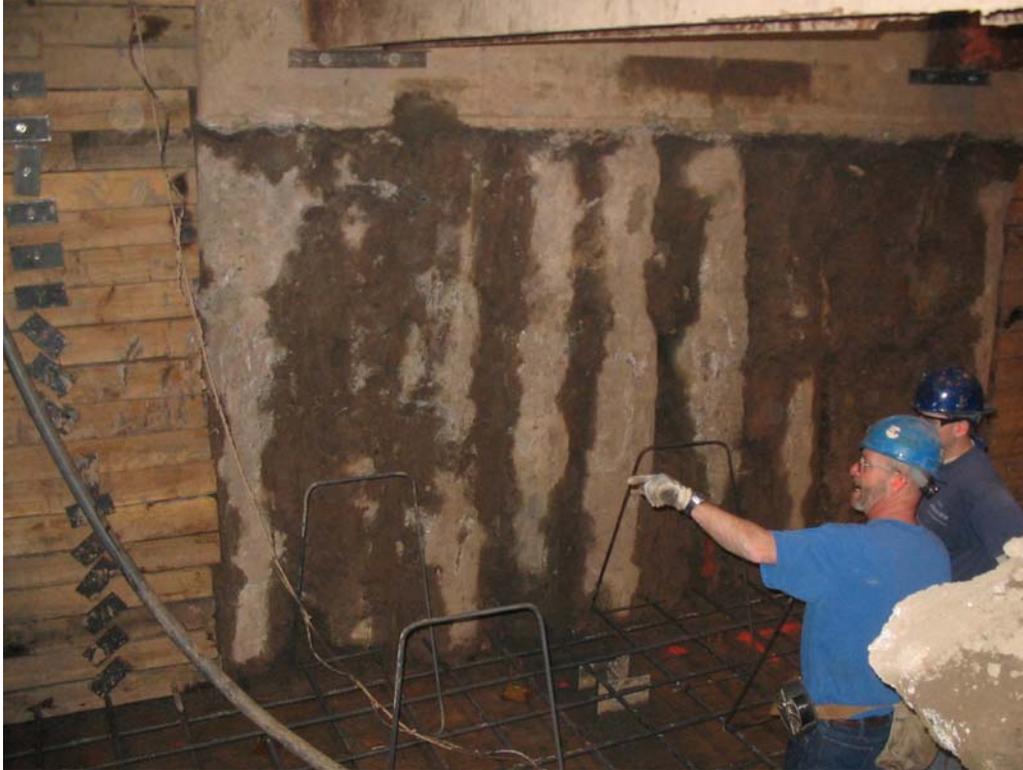
**Figure 10:** Close up view of completed secant pile wall

shows a closer view of the secant pile wall surface.
