HIGH BRIDGE AREA ROADWAY SLIDE,

LETCHWORTH STATE PARK

PORTAGEVILLE, NEW YORK

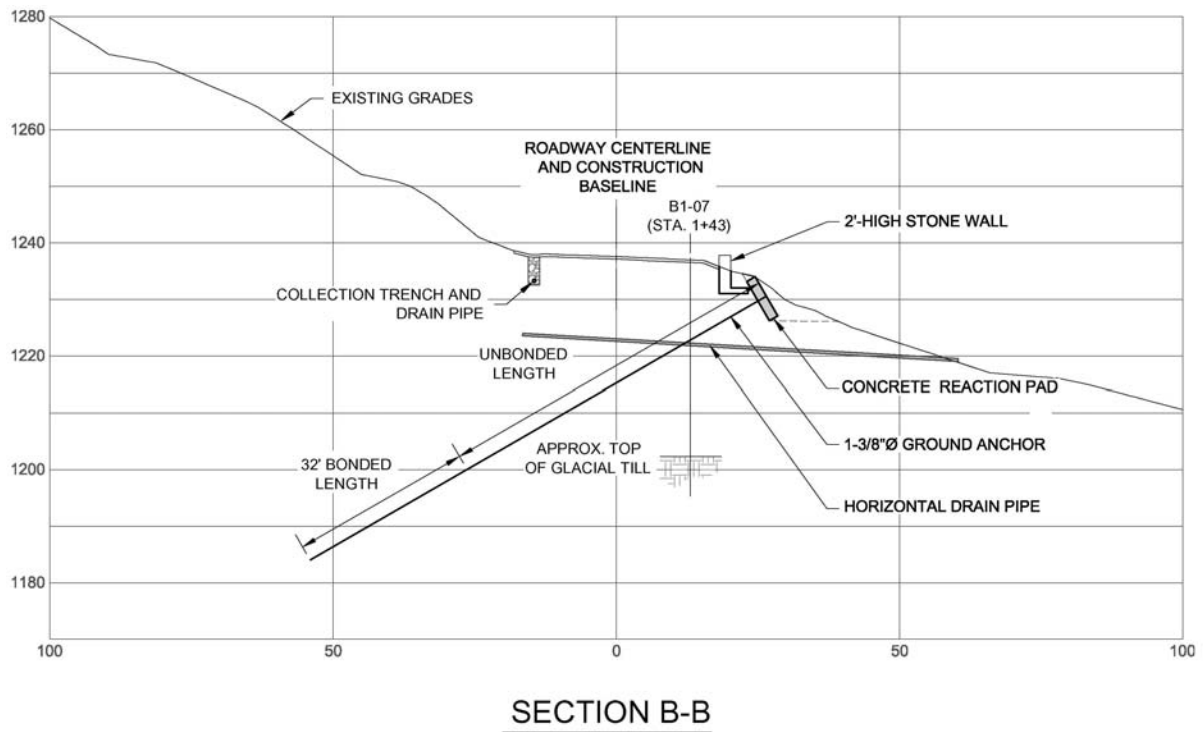
FIGURE 6

Our design includes nine ground anchors and reaction blocks installed below the road. The blocks provide a stabilizing force that increases normal stress on the failure zone to resist future slope movement. Figure 5 shows the reaction blocks and ground anchors in plan and Figure 6 shows them in section view. The reaction blocks and ground anchors could be drilled and grouted into the hillside from a bench area below the road. We also recommended

The design includes two types of drainage systems. A drainage trench approximately 4 feet deep with a perforated pipe surrounded in clean stone is included along the upslope side of the roadway. The purpose of the trench is to collect groundwater from the upper zones of soil and reduce recharge to the silt lenses. Eight horizontal drains that are designed to intercept groundwater in the deeper silt lenses were also included to provide a drainage pathway for the silt lenses during and after tensioning of the ground anchors. The horizontal drains consist of 6-inch diameter slotted drainpipes placed directly in contact with the native site soils. See Figure 6 for the location of the drains in section view.

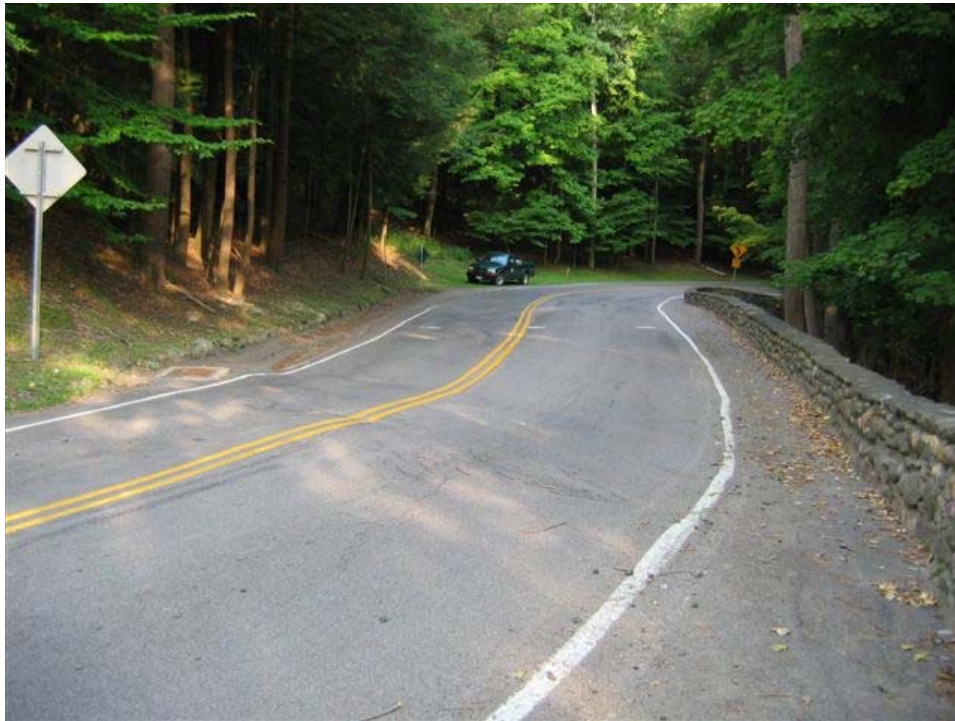
FIGURE 7

bridge were encountering a pavement dip that was nearly 3 feet in depth. Approximately 150 feet of the road was severely cracked and showed signs of significant movement.

OPRHP contracted with Keeler Construction Company, Inc. (Keeler) in the spring of 2008 to reconstruct the roadway and remediate the slope remediation discussed above. Keeler subcontracted with Berkel and Company Contractors, Inc. (Berkel) to construct and install the ground anchors and horizontal drains. BVR Construction Company, Inc. (BVR) was subcontracted to install the reaction blocks. Figure 7 shows the condition of the roadway prior to construction.

Keeler began construction by removing the existing road surface and fill materials that had been placed over the years as the road had continued to move. The upslope subsurface drainage was installed along with new surface water catch basins and outlet pipes. The road sub base was then regraded and compacted using a 2-inch minus crushed stone material. The work progressed down slope of the road by clearing and removing the existing trees and vegetation to allow for installation of the ground anchors and horizontal drains.

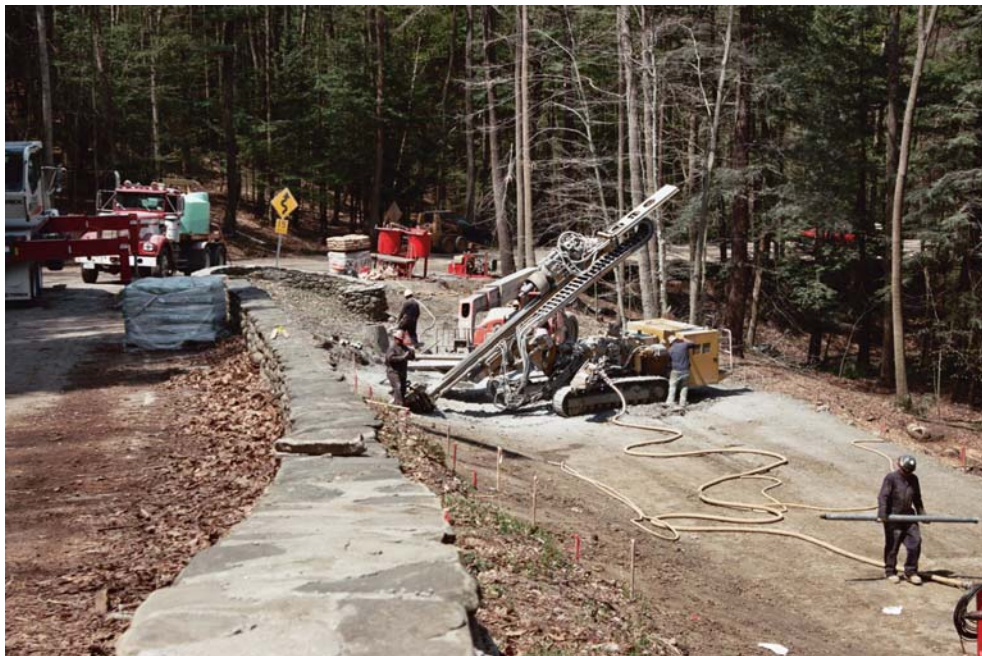
FIGURE 8

Berkel was then mobilized to the site to install the ground anchors and horizontal drains. The subcontractor utilized a horizontal rotary air powered drill rig to drill boreholes to the design lengths shown and advanced steel casing pipe to create a 5-1/4 inch diameter hole to bedrock. Boreholes were advanced without the casing into the bedrock resulting in a 4-1/2-inch diameter hole. Prior to drilling, a cross section at each ground anchor was plotted and

Upon completing each borehole, the DCP bar was inserted and grouted into place. Figure 8 is a photo of the drill rig installing the ground anchors.

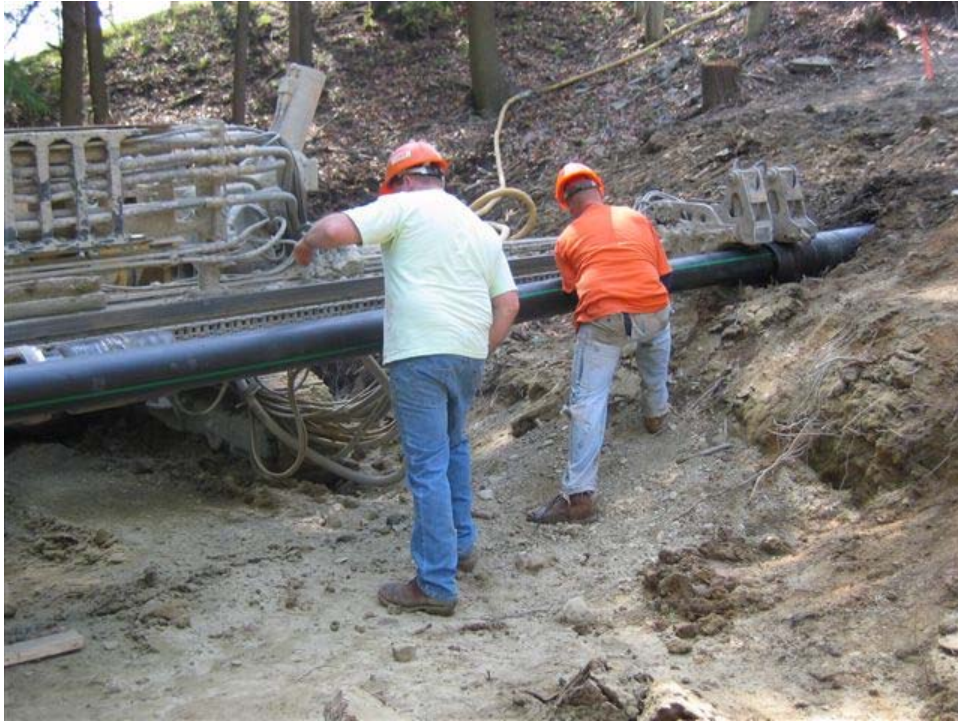
FIGURE 9

Upon completing the ground anchors, Berkel proceeded down slope to the horizontal drain outlet locations. The drain holes were installed using the same drill rig. Upon finishing each borehole, the 6 inch slotted pipe was inserted to the design length and the casing was then removed. The last 10 feet of each pipe was installed without slots and was completed with the installation of an animal guard outlet and riprap apron. Figure 9 is a photo of the drill rig installing the horizontal drains.

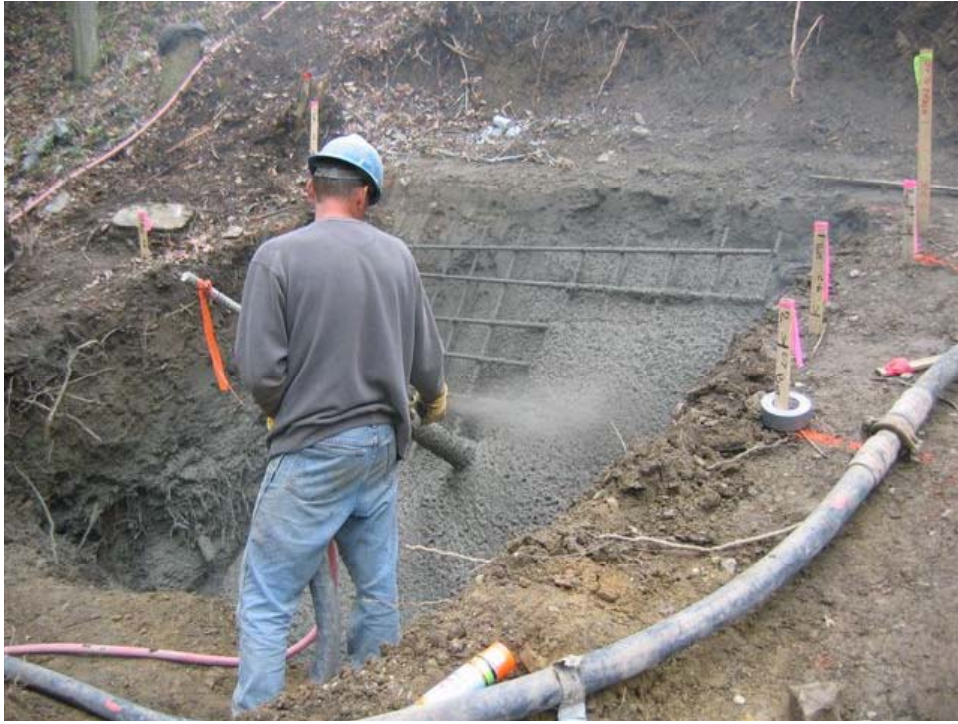
FIGURE 10

BVR was then mobilized to the site to construct the reaction blocks. The design had specified that the reaction blocks be cast in place concrete formed by using shotcrete. This method was chosen to enable the concrete to be placed in intimate contact with the ground surface and constructed without the use of forms.

Prior to placing the shotcrete, BVR installed two mats of reinforcing steel and a protective pipe sleeve to allow the ground anchor to pass through the reaction block. The shotcrete was then installed to the specified thickness with the surface of the blocks troweled to allow for placement of the ground anchor base plate and nut. Figure 10 is a photo of the shotcrete installation.

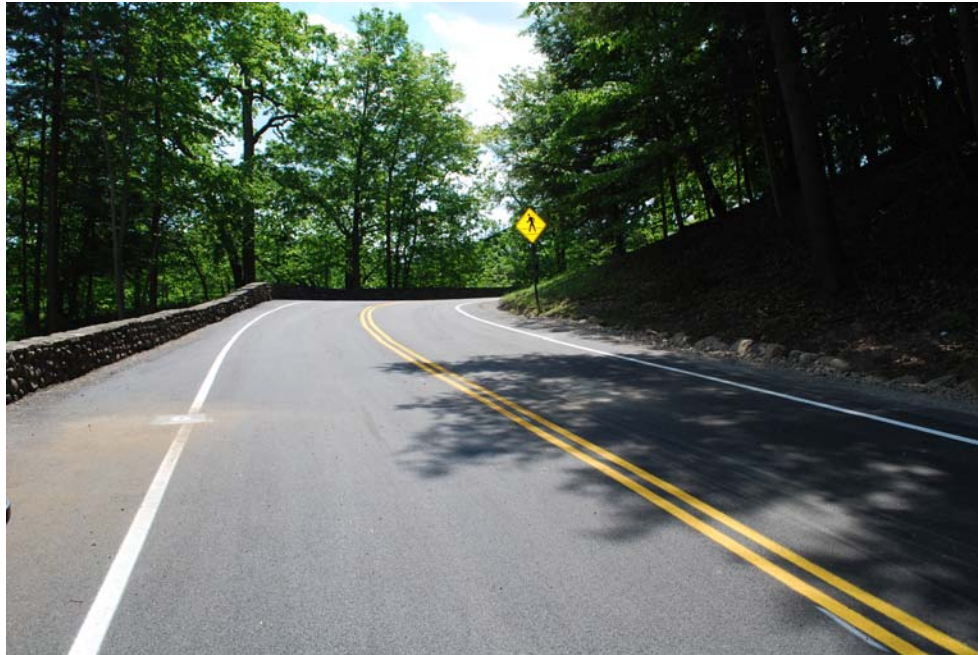
FIGURE 11

Keeler then repaved the roadway and applied topsoil and seed to the completed slope. Figure 11 shows the condition of the roadway at the end of construction.
