**ROCK SLOPE STABILIZATION PROJECTS  
LETCHWORTH STATE PARK  
PORTAGEVILLE, NEW YORK**

**INTRODUCTION**

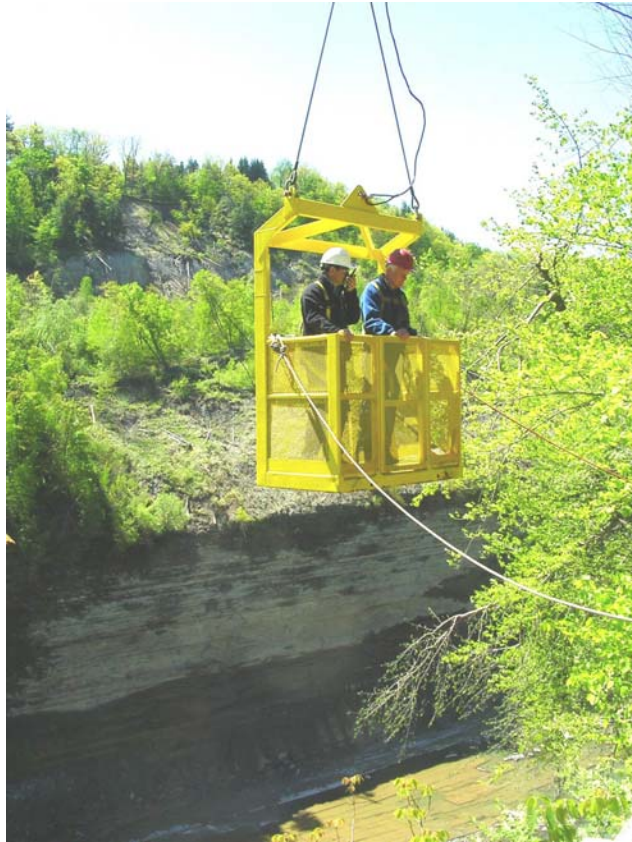
***Figure 3 Man Basket Used for Observations***

MMCE, EDI and OPRHP personnel observed the site conditions in May 2005 with the assistance of a crane and operator provided by Clark Rigging Company. The crane operator lowered personnel over the side of the gorge using a man basket (Figure 3).

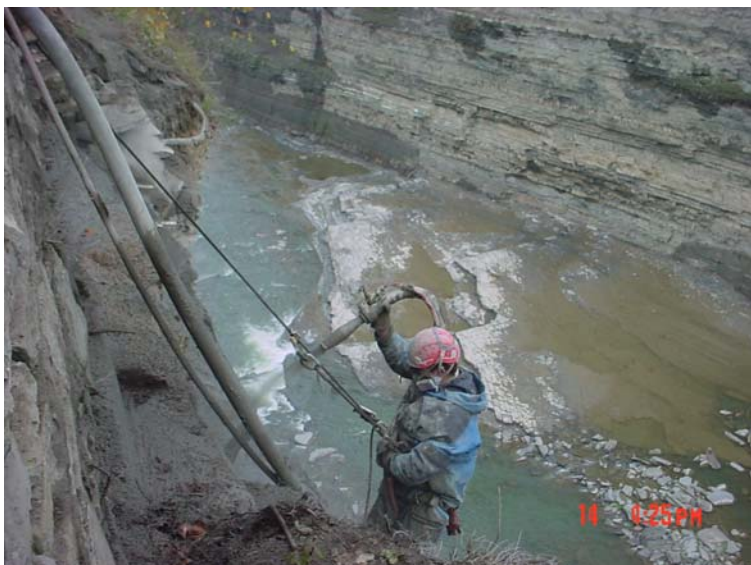
***Figure 12***

Figure 12 shows the shotcrete work in progress. Once the void was partially filled, Janod lowered a drill rig over the side for use in installing the rock anchors, drains and rock nails. Figure 13 shows the rock nail installation and Figure 14 shows the rock anchor installation.

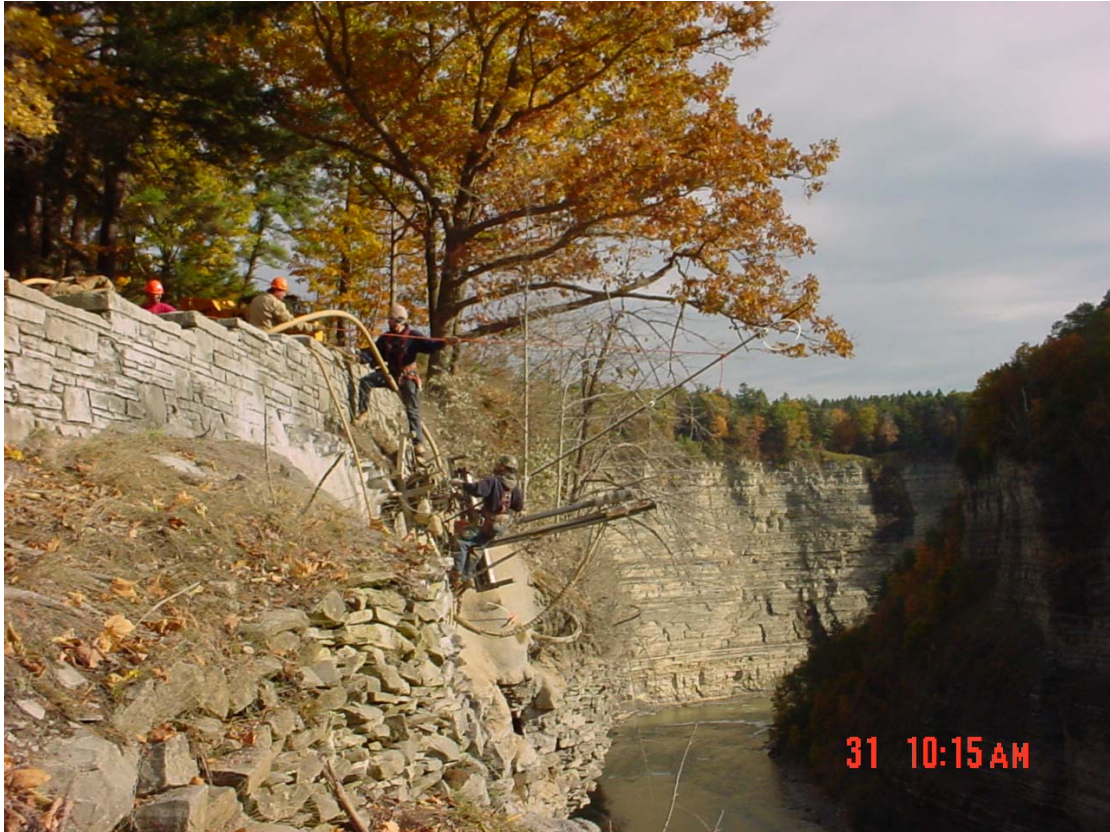
*Figure 13 – Rock Nail Installation*

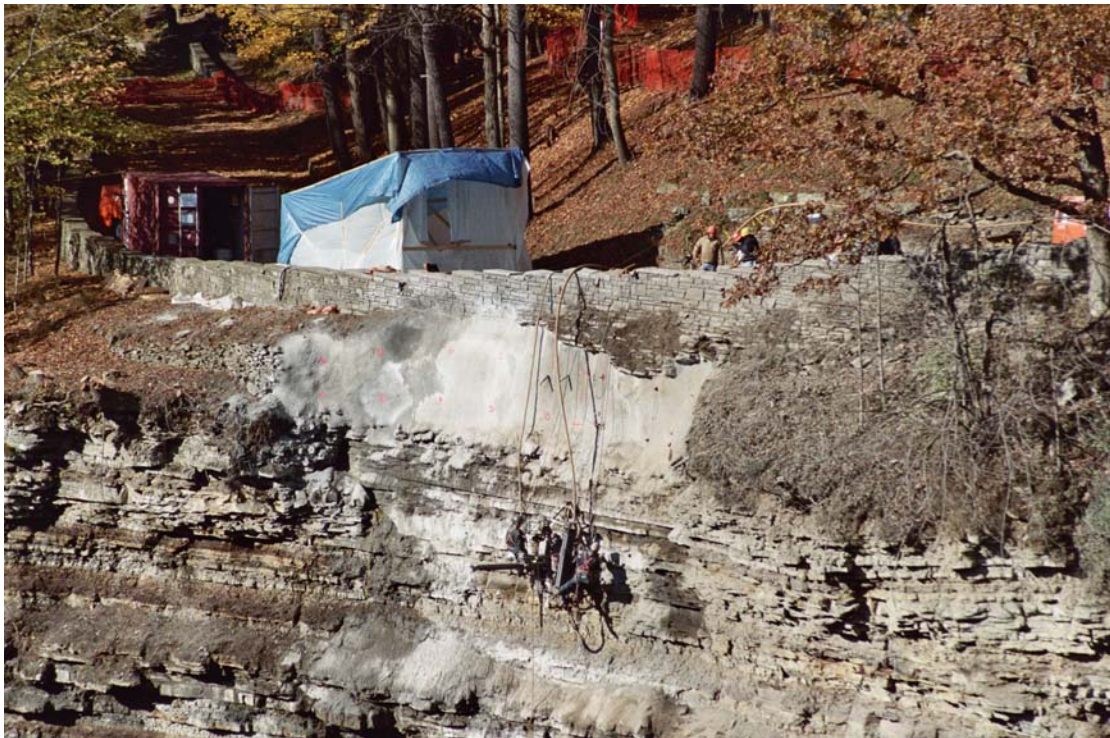
*Figure 14 – Rock Anchor Installation*

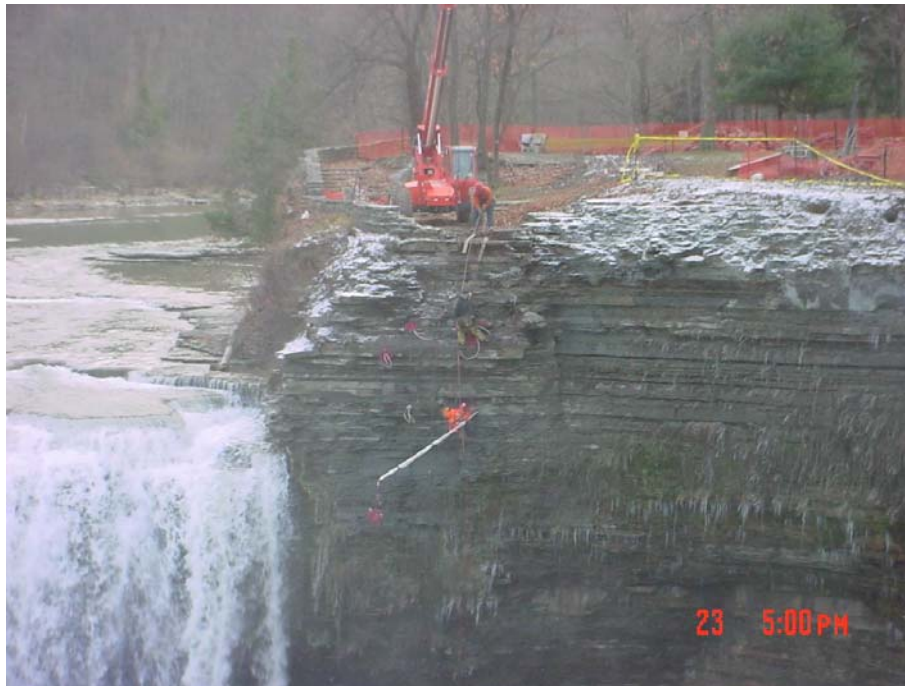
and rock anchors in the loose block as shown in Figures 19 and 20. As for the Gorge Roadway, all of the work was completed from ropes.

***Figure 19 – Janod  
Installing Anchors in  
Block***

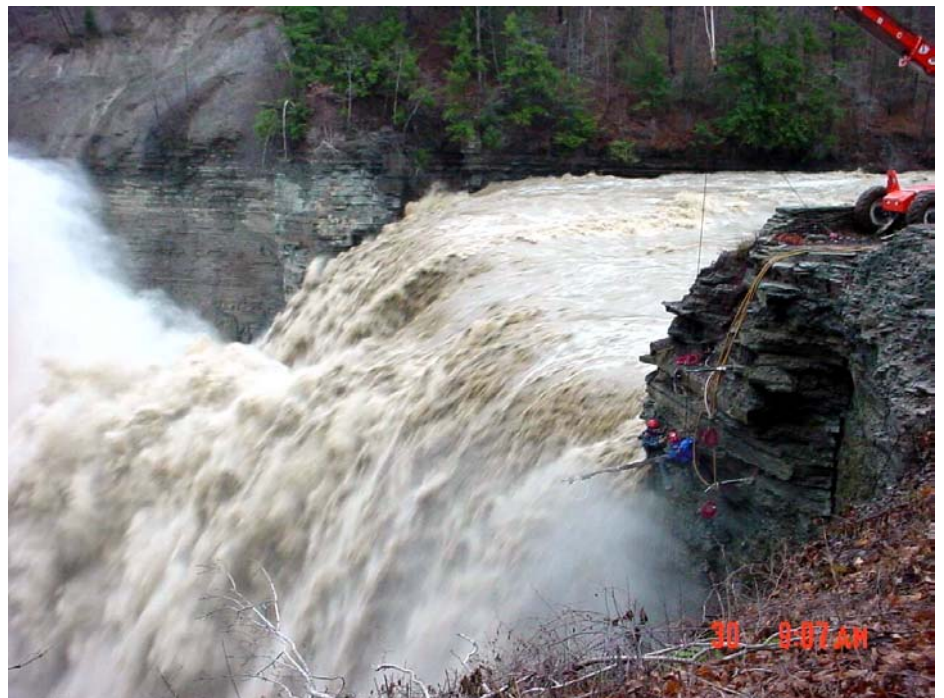
***Figure 20 – Janod Installing  
Rock Anchors on a Rainy Day***

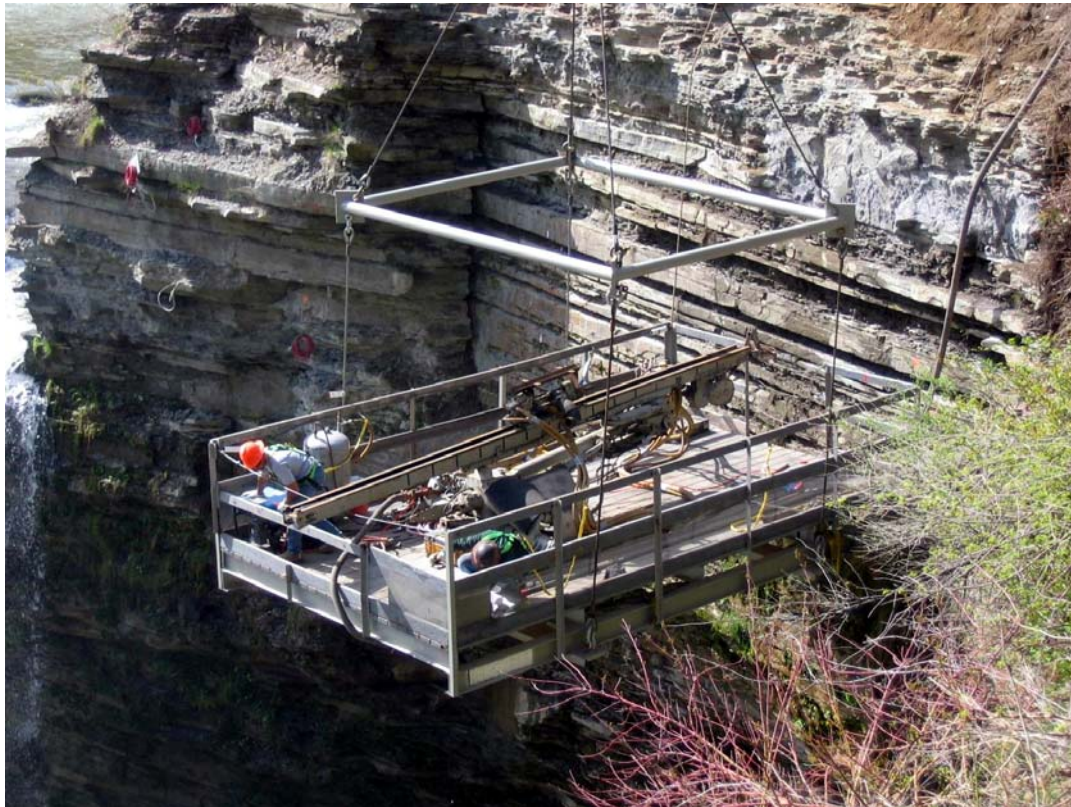
Instead of working from ropes, Nothnagle constructed a work platform as shown on Figure 21. The platform was suspended from a crane and attached to the gorge face with wedge bolts.

***Figure 21 Nothnagle Installing Rock Anchors in the Overhang Area.***

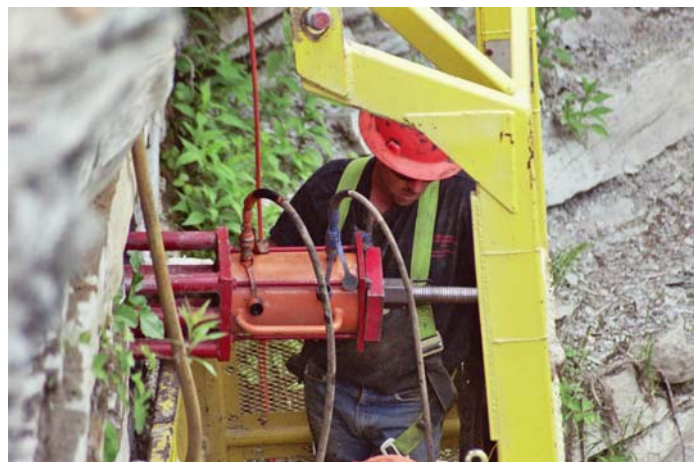
***Figure 22***

Nothnagle completed performance and proof testing on rock anchors and nails. Figure 22 shows an anchor test setup.

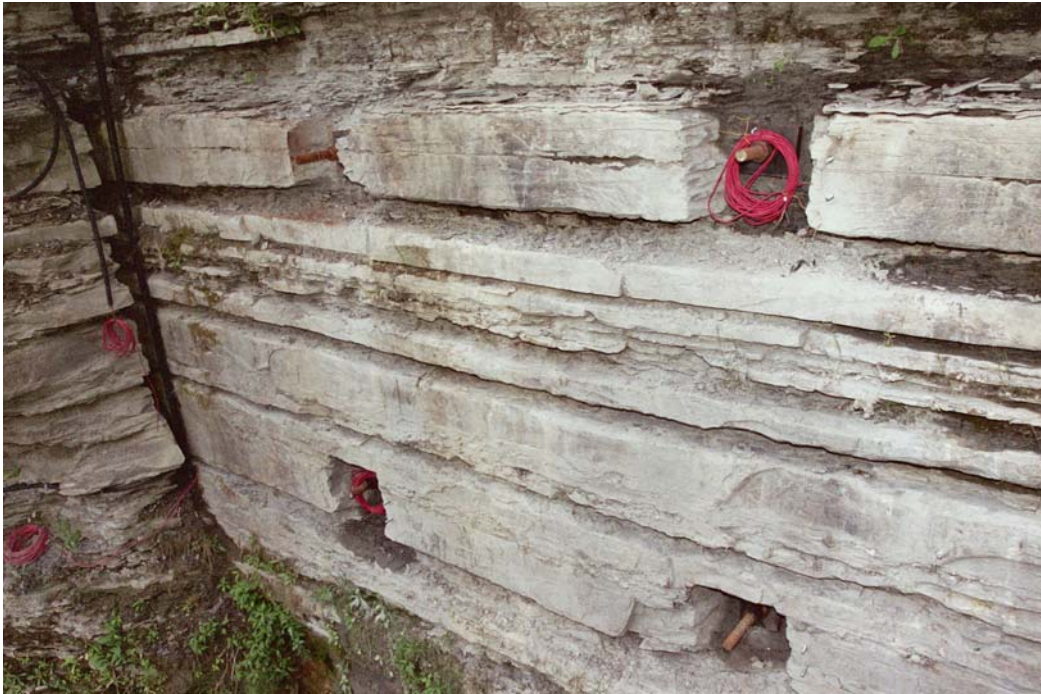
Nothnagle recessed the anchor heads into the rock face as shown on Figure 24. Figure 25 shows the completed project. Although the anchor locations are evident in Figure 25, as the grout has set, it blends with the rock color making the anchor locations imperceptible to those viewing the gorge face.

***Figure 24 Recessed Anchors in Overhang Area***

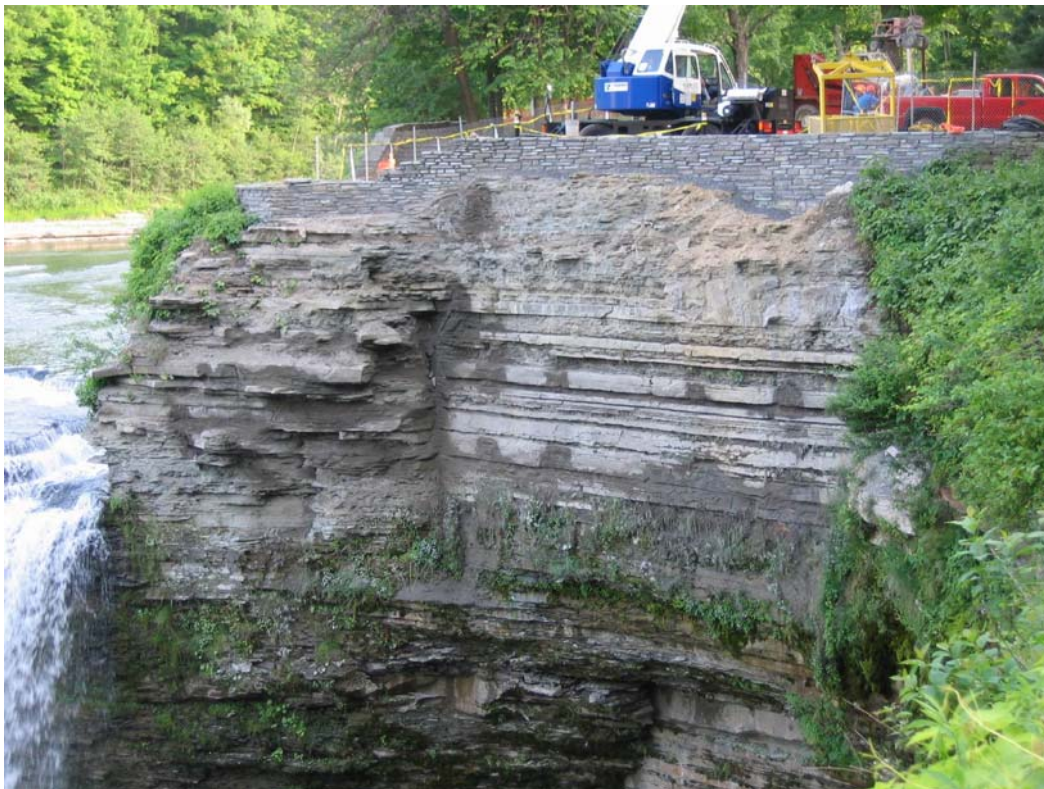
***Figure 25 – Completed Project***
