PROJECT DESCRIPTION

New Oregon Road – Slope Remediation

North Collins, Erie
County, New York

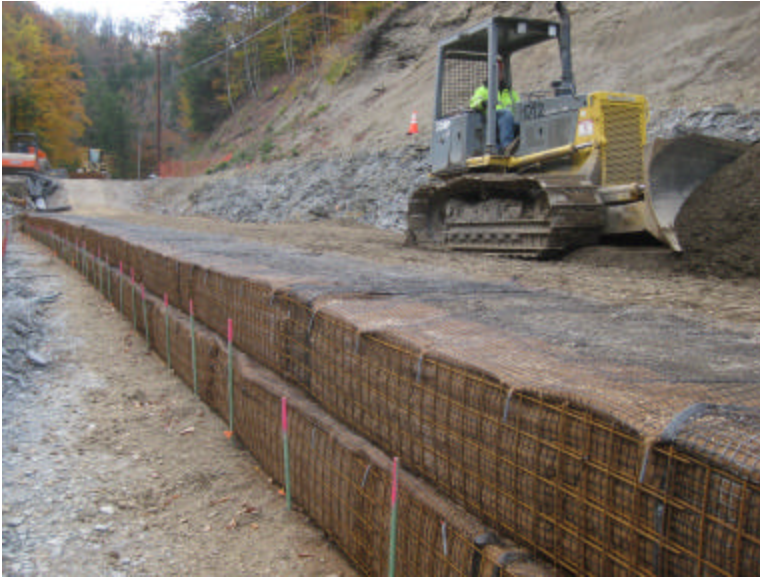
MSE Wall Construction

The site parallels the South Branch of Eighteen Mile Creek, and at this location a steep slope approximately 30 feet high existed between the creek bed and road surface. Over time this slope had experienced erosion, scour and surficial failures, which resulted in pavement failures along the adjacent road.

The geotechnical issue at this site was the topography of competent rock beneath the highway and around the sloughing area. Test borings and test pits were used to measure the edge of shale beneath the road and the inclination of the shale from beneath the highway to the creek bed below. The test pits also allowed for observation of the rock structure. The planned design focused on removing the overburden soils along the highway alignment down to the competent rock surface. A mechanically stabilized earth (MSE) wall was constructed on top of the rock surface to reestablish the road.

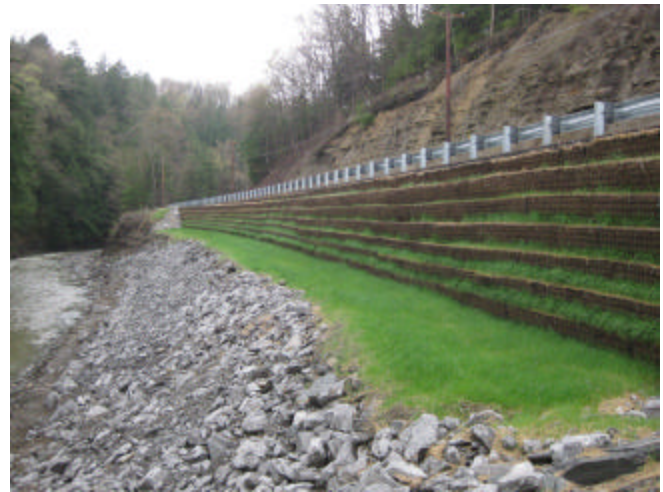
Completed MSE Wall

The MSE wall allowed for a near-vertical 12-foot high slope, which allowed the remainder of the lower slope down to creek to be flattened and covered with rip-rap. During construction, the shale bedrock was observed to establish the bedding and joint patterns. From these observations, bedrock at the site was found to have nearly horizontal bedding planes and a favorable vertical joint structure for supporting the MSE wall.
