## PROJECT DESCRIPTION

### *Zoar Valley Road – Slope Remediation*

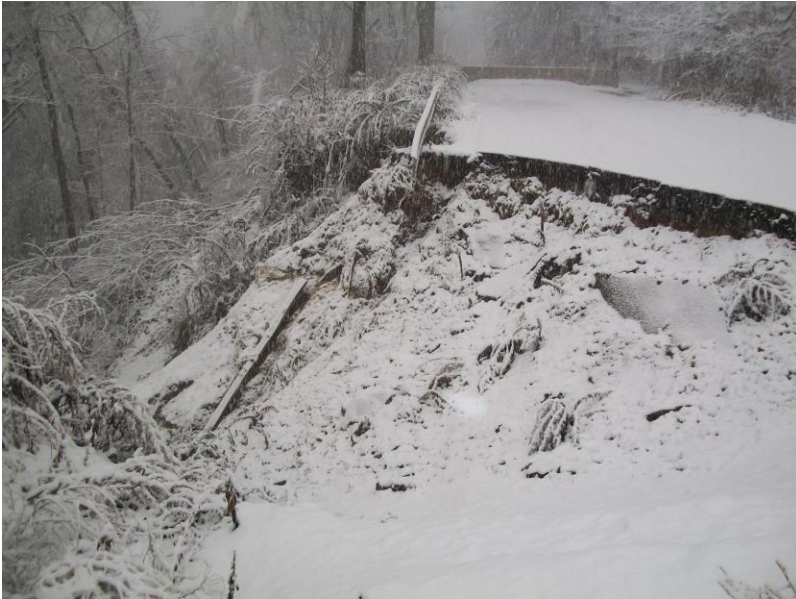
#### ***Road Closed Due to Slope Failure***

The site is located along Zoar Valley Road in the Town of Concord, New York. A slope failure encroached on the road causing the Erie County Department of Public Works to close it at this location. The Federal Emergency Management Agency prepared a project worksheet outlining a proposed scope of work for remediation and mitigation of the site. According to the FEMA project worksheet, during the storms of August 2009, runoff overtopped the road, causing erosion and slope failure.

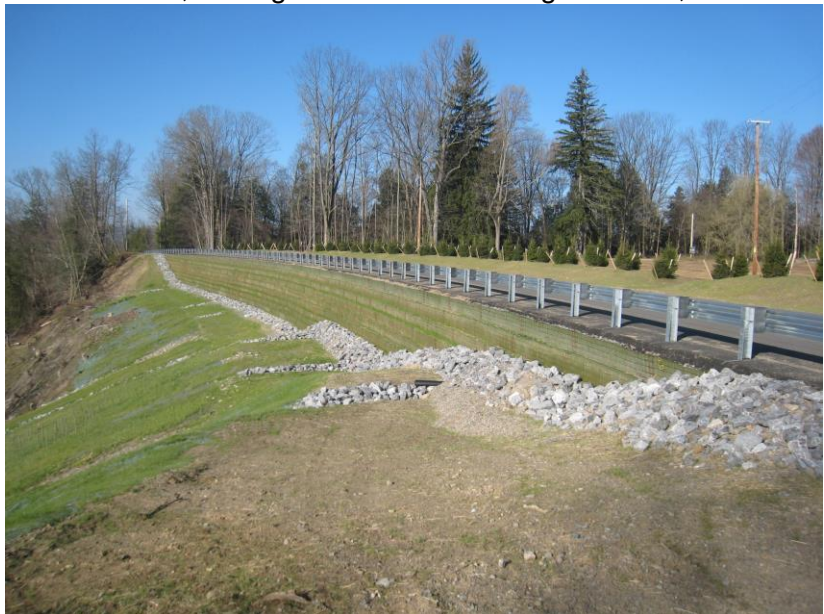
MMCE and Greenman-Pederson prepared a remedial design for the road and slope. The design included a series of drainage trenches and a mechanically stabilized earth wall with a vegetated face. The MSE wall allowed for a steep upper slope, allowing the lower slope down to the creek to be flattened and protected.

#### ***Completed MSE Wall***
