PROJECT DESCRIPTION

Cofferdam for Water Intake Pipeline Repair

North Tonawanda,
New York

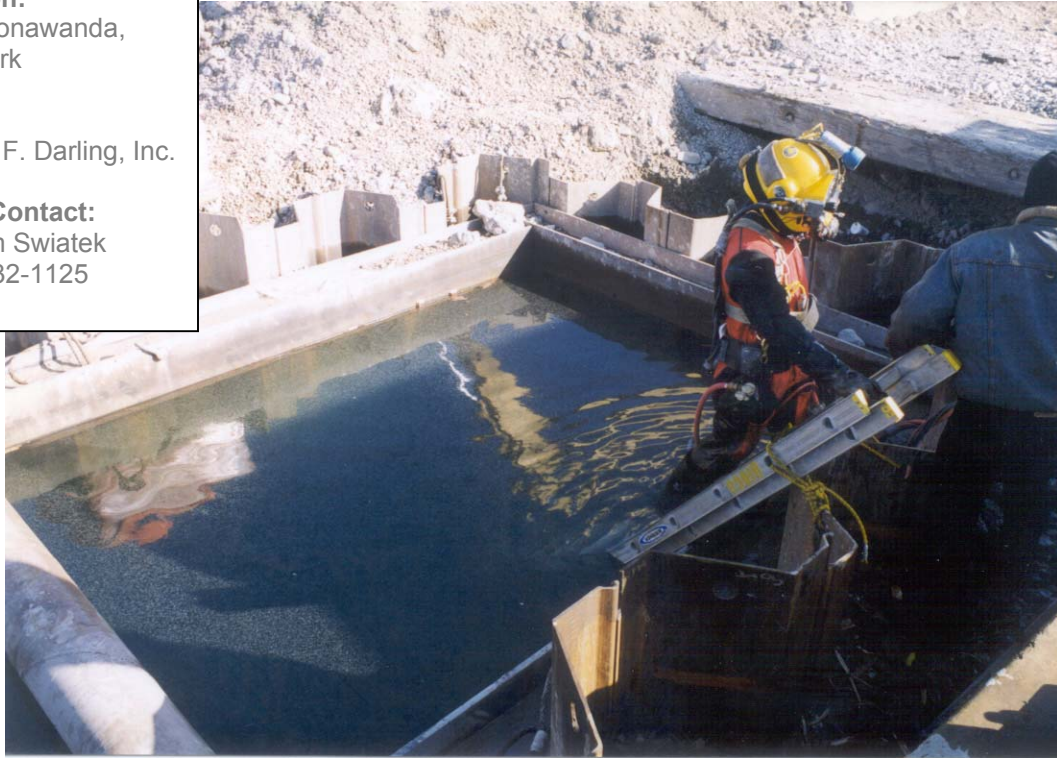
Diver Entering Cofferdam for Pipeline Repair

Darling engaged MMCE to design the cofferdam. First, MMCE studied available subsurface information, which identified a soft clay deposit near the pipe elevation. MMCE designed a sheetpile cofferdam with three levels of horizontal bracing to control adjacent ground movements. The bracing locations were configured so that the excavation contractor could extend the excavation down to below the damaged pipe elevation with its proposed equipment.

The contractor dredged the soil from within the cofferdam. Divers then entered the cofferdam and replaced the damaged pipe. Ground movements to the adjacent marina were limited.
