PROJECT DESCRIPTION

Hopkins Road Landslide Evaluation

Town of Amherst, New York

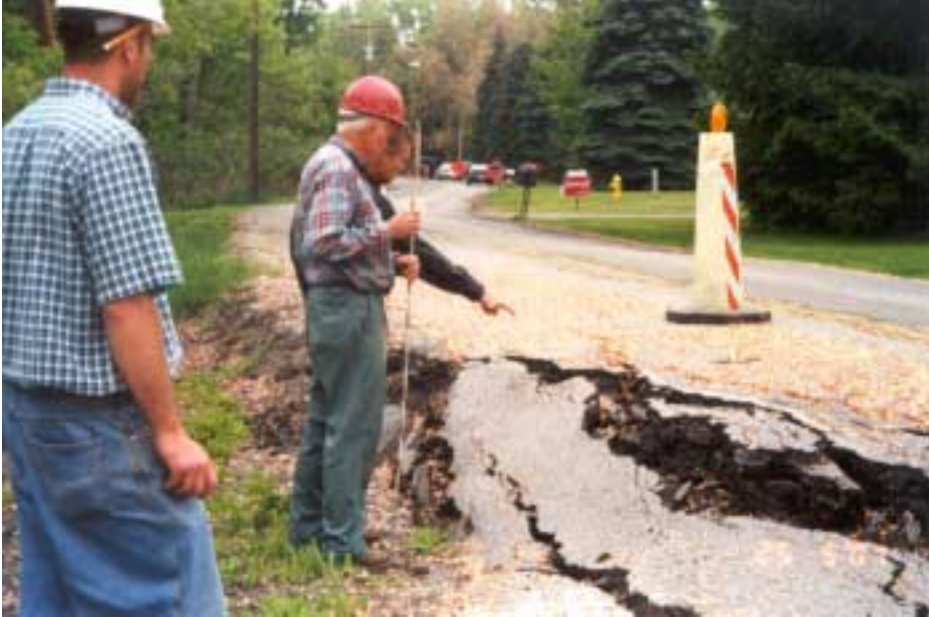
View of Slope Failure Scarp

McMahon & Mann Consulting Engineers, P.C. (MMCE) worked with Wendel Duchscherer to develop alternatives for remediation of several slope failures along Hopkins Road in the Town of Amherst. In five locations between Schoelles Road and Tonawanda Creek Road, the east bank of Ransom Creek has sloughed, affecting the adjacent Hopkins Road pavement. In some of these locations the pavement has experienced cracks that the Erie County DPW has filled. In other areas, the bank sloughing has extended as far as the road centerline, leaving a scarp in the center of the road.

Wendel Duchscherer and MMCE developed design recommendations for remediating the conditions. MMCE also was engaged to develop comparative cost estimates for the remediation options. MMCE's activities included:

- Drilling nine test borings and measuring the strength of the soils in the boreholes using an in-situ vane shear device,
- Evaluated the stability of the existing slope areas,
- Developed recommendations and construction cost estimates for remedial options.
