## PROJECT DESCRIPTION

### *Tonawanda Creek at West Phalinger Road – Slope Remediation*

**Location:**  
Clarence, New York

**Client:**  
Greenman-Pedersen,  
Inc. for Erie County  
Department of Public  
Works

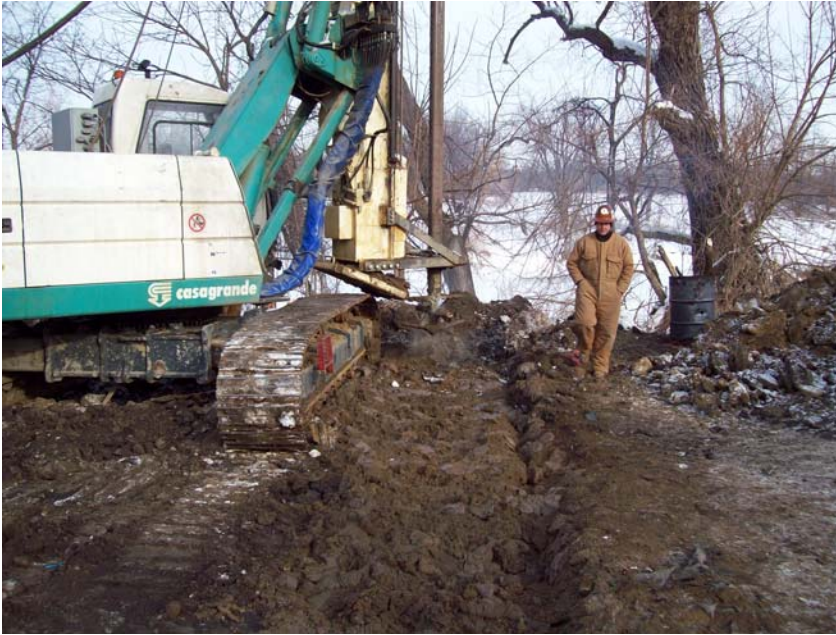
***View of Dry Soil Mixing Operations***

A slope failure along Tonawanda Creek damaged a portion of Tonawanda Creek Road between Transit Road and Westphalinger Road in the Town of Clarence. A section of Tonawanda Creek Road, approximately 250 feet long dropped about 10 feet and pushed soil into Tonawanda Creek. Subsurface explorations indicated that a thick deposit of soft clay was beneath the road.

MMCE developed design recommendations for remediating the soft clay conditions.

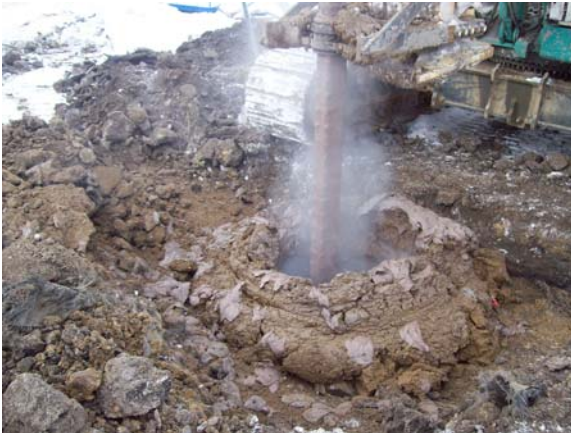
***Soil Cement Column Installation***

Mixing dry cement with the soft clay soils to increase the strength and decrease the compressibility of the soft clay deposit was the selected remediation. MMCE completed stability analysis to determine the amount of improvement that was required to support the reconstructed roadway. Based on the stability analysis, MMCE developed design plans showing the extent of the dry soil mixing improvements. MMCE provided construction monitoring services throughout the project. The project was completed in the winter and early spring of 2009.
